# Access Compliance Report

### (Curb Ramps)

| Intersection ID: 53745 | Main Street: SPRINGWOOD_ESTATE_DR | Cross Street: CANTERBURY_CASTLE_DR | Location: SE |
| ADA ID: 40E3CA46384A | Ramp Type: BlendTrans1 | Initial Pass/Fail: Fail | Overall Compliance: No |

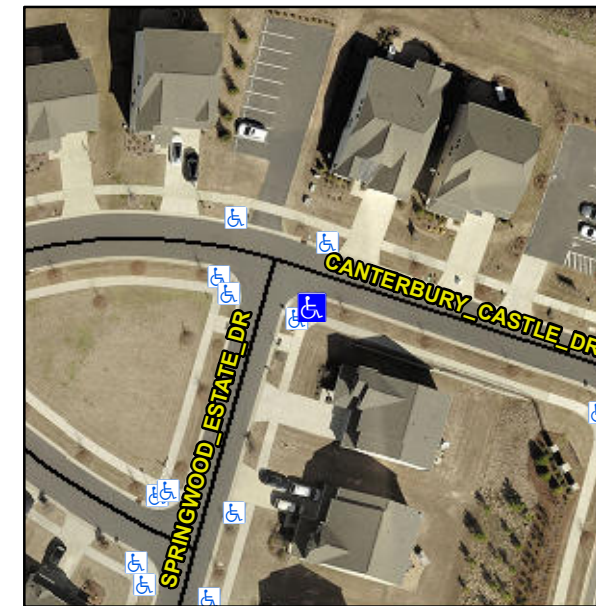
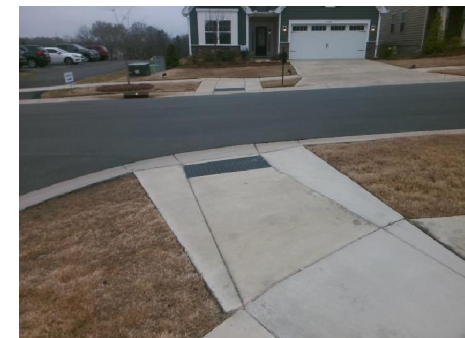
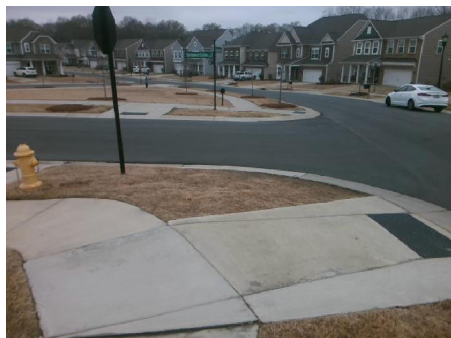
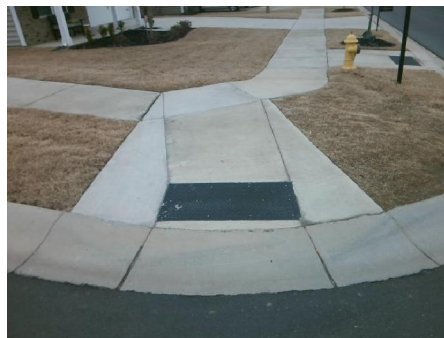
| Severity Score: 12.5 | | | |

| Compliance | Description | Data | Compliance | Description | Data |
|---|---|---|---|---|---|
| Yes | Ramp Width (in) | 48.0 | No | BlendTrans XSlope (%) | 5.3 |

**Remove & Replace Curb Ramp With Two New Directional Ramps or Equivalent.**

**R304.5.3**

Total Cost: \$ 3200.00
