# Access Compliance Report

## Public Rights-of-Way

### (Curb Ramps)

Intersection ID: 3786	Main Street: GALLOWAY_RD	Cross Street: MALLARD_CREEK_RD	Location:	N
ADA ID: 40E7B9A43015	Ramp Type: Perp	Initial Pass/Fail: Fail	Overall Compliance: No	Severity Score: 8.75
Codes/Mitigation Info/Possible Solution		Field Measurements/Component Compliance

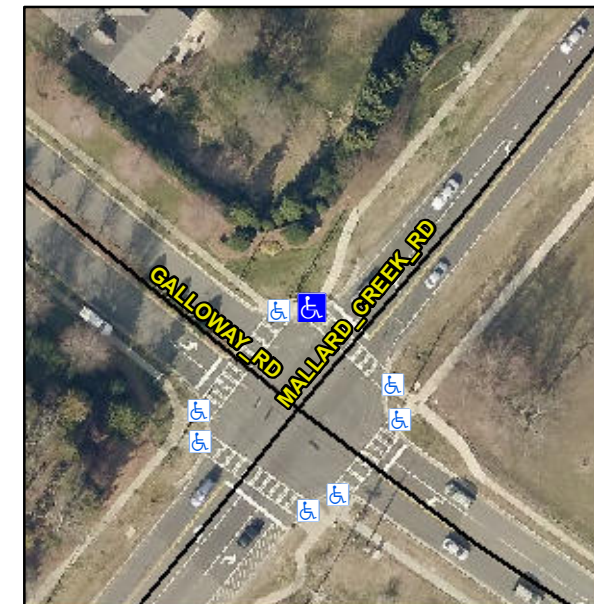
Compliance	Description	Data	Compliance	Description	Data
N/A	Ramp Length (in)	71.0	Yes	Ramp Slope (%)	8.1
No	Ramp Width (in)	46.0	Yes	Ramp XSlope (%)	0.3
N/A	Flare Type LT	N/A	N/A	Flare Type RT	N/A
N/A	Flare Slope LT (%)	N/A	N/A	Flare Slope RT (%)	N/A
N/A	Flare Traversable LT?	N/A	N/A	Flare Traversable RT?	N/A
N/A	Landing Length (in)	N/A	N/A	DWS Provided?	N/A
N/A	Landing Width (in)	N/A	N/A	DWS Contrast?	N/A
N/A	Landing Slope (%)	N/A	N/A	DWS Length (in)	N/A
N/A	Landing X Slope (%)	N/A	N/A	DWS Full Width?	N/A
N/A	Landing Curb? (Y/N)	N/A	N/A	DWS Offset (in)	N/A
N/A	Shared Landing?	N/A			
N/A	Gutter Ponding?	N/A	N/A	Gutter Slope (%)	N/A
N/A	Gutter Lip Ht (in)	N/A	N/A	Gutter X Slope (%)	N/A
N/A	Painted X Walk1?	Yes	N/A	Painted X Walk2?	N/A
	X Walk 1 Direction	To SE		X Walk 2 Direction	N/A
N/A	X Walk 1 Width (in)	109.0	N/A	X Walk 2 Width (in)	N/A
	X Walk 1 Slope (%)	3.8		X Walk 2 Slope (%)	N/A
	X Walk 1 X Slope (%)	1.2		X Walk 2 X Slope (%)	N/A

N/A	Ramp inside XWalk1?	Yes	N/A	Ramp inside XWalk2?	N/A
	Road Slope (%)	N/A	N/A	Clear Space?	N/A
	Road X Slope (%)	N/A	N/A	Clear Space to XWalk (in)	N/A
N/A	Any Obstructions?	N/A	N/A	Storm Grate/Utility Hazard?	N/A
	Obstruction Type			Storm Grate/Utility Type	
		N/A			N/A
			Yes	Surface Condition? (G/P)	Good

Possible Solutions:

**Remove & Replace Entire Ramp.**

**R304.5.1**

Total Cost: \$ 1850.00
