Access Compliance Report Public Rights-of-Way (Curb Ramps)

Intersection ID: 3603 Main Street: MOUNTAIN PARK DR Cross Street: MT ISLE HARBOR DR Location: NW **Overall Compliance: No Severity Score:** ADA ID: 4111AF287965 Ramp Type: Perp Initial Pass/Fail: Fail 12.5

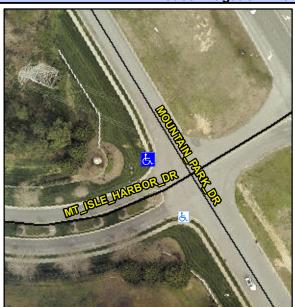
Total Cost: 1850.00 Compliance Description Data Compliance Description Data No N/A Ramp Length (in) 47.5 Ramp Slope (%) 8.7 Yes Ramp XSlope (%) Yes Ramp Width (in) 48.0 1.8 N/A N/A Flare Type LT N/A Flare Type RT N/A N/A N/A N/A Flare Slope RT (%) N/A Flare Slope LT (%) N/A Flare Traversable LT? N/A N/A Flare Traversable RT? N/A N/A N/A N/A **DWS Provided?** N/A Landing Length (in) N/A Landing Width (in) N/A N/A **DWS Contrast?** N/A N/A N/A N/A Landing Slope (%) DWS Length (in) N/A N/A Landing X Slope (%) N/A N/A DWS Full Width? N/A N/A Landing Curb? (Y/N) N/A N/A DWS Offset (in) N/A N/A N/A Shared Landing? N/A **Gutter Ponding?** N/A N/A Gutter Slope (%) N/A N/A Gutter Lip Ht (in) N/A N/A Gutter X Slope (%) N/A N/A Painted X Walk1? No N/A Painted X Walk2? N/A X Walk 1 Direction To S X Walk 2 Direction N/A N/A N/A X Walk 2 Width (in) X Walk 1 Width (in) N/A X Walk 1 Slope (%) 0.1 X Walk 2 Slope (%) N/A X Walk 1 X Slope (%) 3.5 X Walk 2 X Slope (%) N/A N/A N/A N/A Ramp inside XWalk2? Ramp inside XWalk1? N/A Road Slope (%) N/A N/A Clear Space? N/A N/A Road X Slope (%) N/A Clear Space to XWalk (in) N/A N/A N/A Any Obstructions? N/A Storm Grate/Utility Hazard? N/A **Obstruction Type** Storm Grate/Utility Type N/A N/A Yes Surface Condition? (G/P) Good

MT ISLE HARBOR DR Street 1 Name Stop Condition-Street 2 StopSign N/A Street 2 Name Stop Condition-Street 1 N/A Possible Solutions: Remove & Replace Entire Ramp. Surveyor Notes: N/A PROW/ADA: Not Found, R304.2.2
