Access Compliance Report

Public Rights-of-Way

(Curb Ramps)

Intersection ID: 18012	Main Street: RAMA_RD	Cross Street: CHARING_PL	Location: SE
ADA ID: 411BE508FA7A	Ramp Type: PerpDiag	Initial Pass/Fail: Fail	Overall Compliance: No
		Severity Score: 37.5

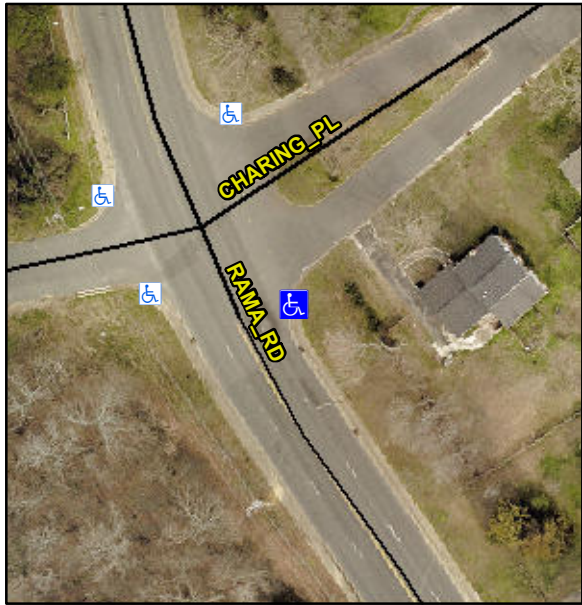
Possible Solutions:		Compliance	Description	Data	Compliance	Description	Data
	Remove & Replace Curb Ramp With Two New Directional Ramps or Equivalent.		N/A	Ramp Length (in)	59.5	No	Ramp Slope (%)	13.1
			Yes	Ramp Width (in)	48.0	No	Ramp XSlope (%)	5.6
			N/A	Flare Type LT	N/A	N/A	Flare Type RT	N/A
			N/A	Flare Slope LT (%)	N/A	N/A	Flare Slope RT (%)	N/A
			N/A	Flare Traversable LT?	N/A	N/A	Flare Traversable RT?	N/A
			N/A	Landing Length (in)	N/A	N/A	DWS Provided?	N/A
			N/A	Landing Width (in)	N/A	N/A	DWS Contrast?	N/A
			N/A	Landing Slope (%)	N/A	N/A	DWS Length (in)	N/A
			N/A	Landing X Slope (%)	N/A	N/A	DWS Full Width?	N/A
Surveyor Notes:		N/A	N/A	Landing Curb? (Y/N)	N/A	N/A	DWS Offset (in)	N/A
PROW/ADA:		Not Found, R304.2.2, R304.5.3	N/A	Shared Landing?	N/A			
			N/A	Gutter Ponding?	N/A	N/A	Gutter Slope (%)	N/A

N/A	Gutter Lip Ht (in)	N/A	N/A	Gutter X Slope (%)	N/A
			N/A	Painted X Walk1?	No	N/A	Painted X Walk2?	No
				X Walk 1 Direction	To N		X Walk 2 Direction	To NW
			N/A	X Walk 1 Width (in)	N/A	N/A	X Walk 2 Width (in)	N/A
				X Walk 1 Slope (%)	1.9		X Walk 2 Slope (%)	3.9
				X Walk 1 X Slope (%)	3.4		X Walk 2 X Slope (%)	1.8
			N/A	Ramp inside XWalk1?	N/A	N/A	Ramp inside XWalk2?	N/A
				Road Slope (%)	5.1	N/A	Clear Space?	N/A
				Road X Slope (%)	2.3	N/A	Clear Space to XWalk (in)	N/A
			N/A	Any Obstructions?	N/A	N/A	Storm Grate/Utility Hazard?	N/A
				Obstruction Type			Storm Grate/Utility Type	
					N/A			N/A
						Yes	Surface Condition? (G/P)	Good
Street 1 Name		CHARING PL						
Stop Condition-Street 2		StopSign						
Street 2 Name		RAMA RD						
Stop Condition-Street 1		None						
Total Cost:		\$ 3200.00
