Access Compliance Report

Public Rights-of-Way

(Curb Ramps)

Intersection ID: 42670	Main Street: WALLACE_CABIN_DR	Cross Street: WALLACE_CREEK_LN	Location: SW
ADA ID: 413115E79BEC	Ramp Type: PerpDiag	Initial Pass/Fail: Fail	Overall Compliance: No
			Severity Score: 21.25

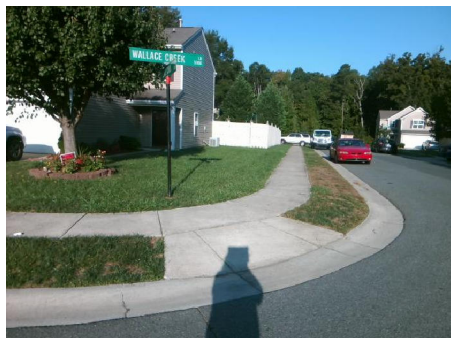
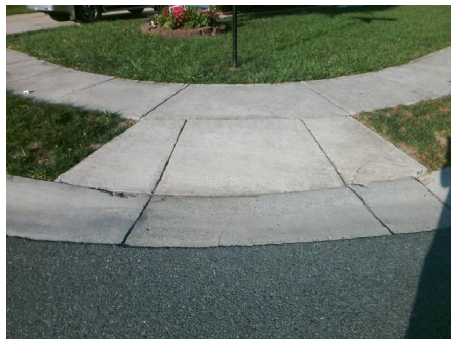
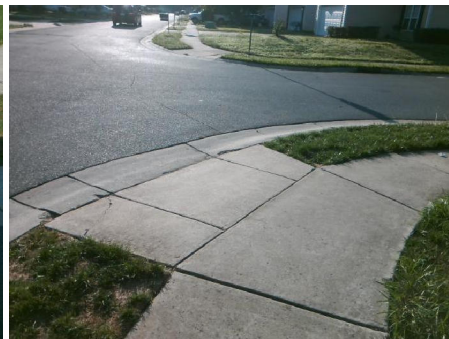
N/A	Landing Curb? (Y/N)	N/A	N/A	DWS Offset (in)	N/A
N/A	Shared Landing?	N/A			
N/A	Gutter Ponding?	N/A	N/A	Gutter Slope (%)	N/A
N/A	Gutter Lip Ht (in)	N/A	N/A	Gutter X Slope (%)	N/A
N/A	Painted X Walk1?	No	N/A	Painted X Walk2?	No
	X Walk 1 Direction	To E		X Walk 2 Direction	To N
N/A	X Walk 1 Width (in)	N/A	N/A	X Walk 2 Width (in)	N/A
	X Walk 1 Slope (%)	2.1		X Walk 2 Slope (%)	3.1
	X Walk 1 X Slope (%)	2.4		X Walk 2 X Slope (%)	1.3
N/A	Ramp inside XWalk1?	N/A	N/A	Ramp inside XWalk2?	N/A
	Road Slope (%)	1.9	N/A	Clear Space?	N/A
	Road X Slope (%)	3.2	N/A	Clear Space to XWalk (in)	N/A
N/A	Any Obstructions?	N/A	N/A	Storm Grate/Utility Hazard?	N/A
	Obstruction Type			Storm Grate/Utility Type	
		N/A			N/A
			Yes	Surface Condition? (G/P)	Good

Possible Solutions:				
	Remove & Replace Curb Ramp With Two New Directional Ramps or Equivalent.				
	Surveyor Notes:				
	N/A				
	PROW/ADA:				
	R304.5.1, R304.2.2				
	Street 1 Name	WALLACE CREEK LN			
	Stop Condition-Street 2	StopSign			
	Street 2 Name	WALLACE CABIN DR			
	Stop Condition-Street 1	None			
	Total Cost:	\$ 3200.00			
Compliance	Description	Data	Compliance	Description	Data
N/A	Ramp Length (in)	49.5	No	Ramp Slope (%)	10.8
No	Ramp Width (in)	46.5	Yes	Ramp XSlope (%)	1.2
N/A	Flare Type LT	N/A	N/A	Flare Type RT	N/A
N/A	Flare Slope LT (%)	N/A	N/A	Flare Slope RT (%)	N/A
N/A	Flare Traversable LT?	N/A	N/A	Flare Traversable RT?	N/A
N/A	Landing Length (in)	N/A	N/A	DWS Provided?	N/A
N/A	Landing Width (in)	N/A	N/A	DWS Contrast?	N/A
N/A	Landing Slope (%)	N/A	N/A	DWS Length (in)	N/A
N/A	Landing X Slope (%)	N/A	N/A	DWS Full Width?	N/A
