Access Compliance Report

Public Rights-of-Way

(Curb Ramps)

Intersection ID: 27742	Main Street: BREM_LN	Cross Street: OLD_WAYSIDE_RD	Location: SW
ADA ID: 41354C1577CF	Ramp Type: BlendTrans2	Initial Pass/Fail: Fail	Overall Compliance: No
		Severity Score: 25

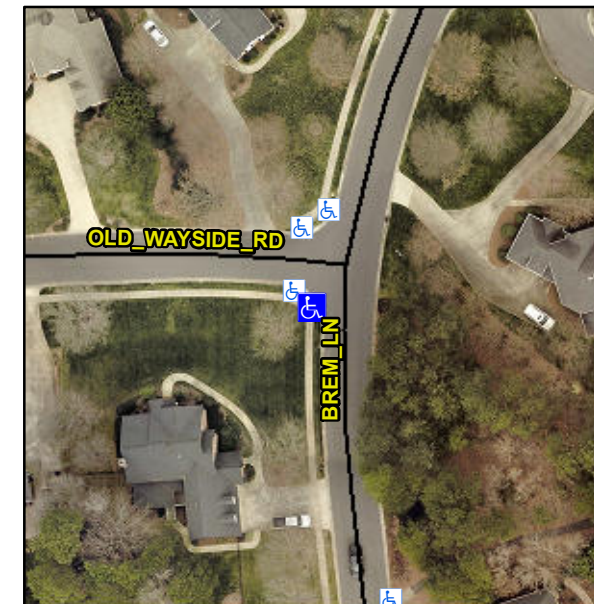
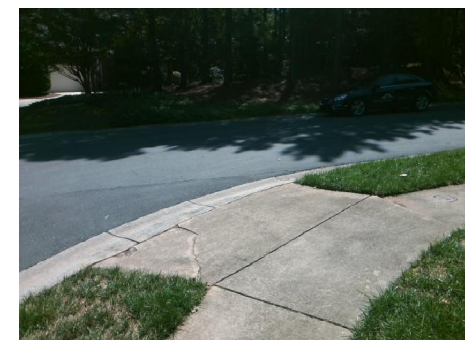
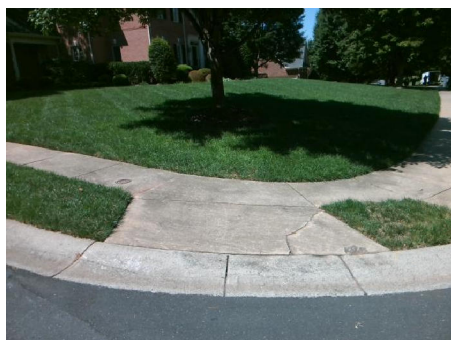
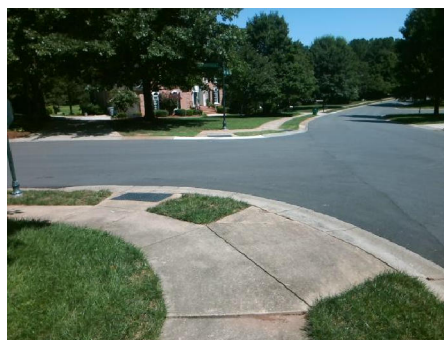
Not Found, R304.5.3

Compliance	Description	Data	Compliance	Description	Data
N/A	Ramp Length (in)	94.0	Yes	BlendTrans Slope (%)	4.1
Yes	Ramp Width (in)	48.0	No	BlendTrans XSlope (%)	8.0
N/A	Flare Type LT	N/A	N/A	Flare Type RT	N/A
N/A	Flare Slope LT (%)	N/A	N/A	Flare Slope RT (%)	N/A
N/A	Flare Traversable LT?	N/A	N/A	Flare Traversable RT?	N/A
N/A	Landing Length (in)	N/A	N/A	DWS Provided?	N/A
N/A	Landing Width (in)	N/A	N/A	DWS Contrast?	N/A
N/A	Landing Slope (%)	N/A	N/A	DWS Length (in)	N/A
N/A	Landing X Slope (%)	N/A	N/A	DWS Full Width?	N/A
N/A	Landing Curb? (Y/N)	N/A	N/A	DWS Offset (in)	N/A
N/A	Shared Landing?	N/A			
N/A	Gutter Ponding?	N/A	N/A	Gutter Slope (%)	N/A
N/A	Gutter Lip Ht (in)	N/A	N/A	Gutter X Slope (%)	N/A
N/A	Painted X Walk1?	No	N/A	Painted X Walk2?	N/A
	X Walk 1 Direction	To E		X Walk 2 Direction	N/A
	X Walk 1 Width (in)	N/A		X Walk 2 Width (in)	N/A
	X Walk 1 Slope (%)	3.6		X Walk 2 Slope (%)	N/A
	X Walk 1 X Slope (%)	4.3		X Walk 2 X Slope (%)	N/A

N/A	Ramp inside XWalk1?	N/A	N/A	Ramp inside XWalk2?	N/A
	Road Slope (%)	4.3		Clear Space?	N/A
	Road X Slope (%)	3.6	N/A	Clear Space to XWalk (in)	N/A
N/A	Any Obstructions?	N/A	N/A	Storm Grate/Utility Hazard?	N/A
	Obstruction Type			Storm Grate/Utility Type	
		N/A			N/A
			Yes	Surface Condition? (G/P)	Good
			No	Curb Slope (%)	9.5

Remove & Replace Curb Ramp With Two New Directional Ramps or Equivalent.
