Access Compliance Report Public Rights-of-Way (Curb Ramps)

Intersection ID: 48196 Main Street: BLAKENEY_PARK_DR Cross Street: REA_RD Location: N

ADA ID: 4142AD66B3EC Ramp Type: Perp Initial Pass/Fail: Fail Overall Compliance: No Severity Score: 8.75

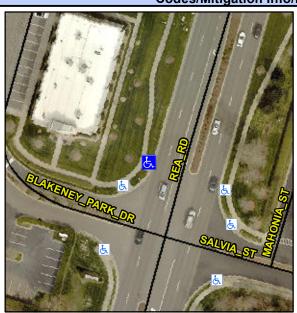
Field Measure	ements/C	ompo	nent Compliance	
Compliance Description Date			Comp	liance Description	Data
N/A	Ramp Length (in)	91.0	Yes	Ramp Slope (%)	6.6
No	Ramp Width (in)	46.0	Yes	Ramp XSlope (%)	0.5
N/A	Flare Type LT	N/A	N/A	Flare Type RT	N/A
N/A	Flare Slope LT (%)	N/A	N/A	Flare Slope RT (%)	N/A
N/A	Flare Traversable LT?	N/A	N/A	Flare Traversable RT?	N/A
N/A	Landing Length (in)	N/A	N/A	DWS Provided?	N/A
N/A	Landing Width (in)	N/A	N/A	DWS Contrast?	N/A
N/A	Landing Slope (%)	N/A	N/A	DWS Length (in)	N/A
N/A	Landing X Slope (%)	N/A	N/A	DWS Full Width?	N/A
N/A	Landing Curb? (Y/N)	N/A	N/A	DWS Offset (in)	N/A
N/A	Shared Landing?	N/A			
N/A	Gutter Ponding?	N/A	N/A	Gutter Slope (%)	N/A
N/A	Gutter Lip Ht (in)	N/A	N/A	Gutter X Slope (%)	N/A
N/A	Painted X Walk1?	No	N/A	Painted X Walk2?	N/A
	X Walk 1 Direction	To SE		X Walk 2 Direction	N/A
N/A	X Walk 1 Width (in)	N/A	N/A	X Walk 2 Width (in)	N/A
	X Walk 1 Slope (%)	3.1		X Walk 2 Slope (%)	N/A

X Walk 1 X Slope (%)	0.5		X Walk 2 X Slope (%)	N/A
N/A	Ramp inside XWalk1?	N/A	N/A	Ramp inside XWalk2?	N/A
	Road Slope (%)	N/A	N/A	Clear Space?	N/A
	Road X Slope (%)	N/A	N/A	Clear Space to XWalk (in)	N/A
N/A	Any Obstructions?	N/A	N/A	Storm Grate/Utility Hazard?	N/A
	Obstruction Type			Storm Grate/Utility Type	
		N/A			N/A
			Yes	Surface Condition? (G/P)	Good

Possible Solutions:						
Remove & Replace Entire Ramp.						
Cumyayar Nataa						
Surveyor Notes:						
N/A						
PROW/ADA:						
R304.5.1
