Access Compliance Report

Public Rights-of-Way (Curb Ramps)

Intersection ID: N/A	Main Street: AGNEW_DR	Cross Street: COWGILL_LN	Location: SW
ADA ID: 4145482E3EF4	Ramp Type: Perp	Initial Pass/Fail: Pass	Overall Compliance: No
		Severity Score: 0

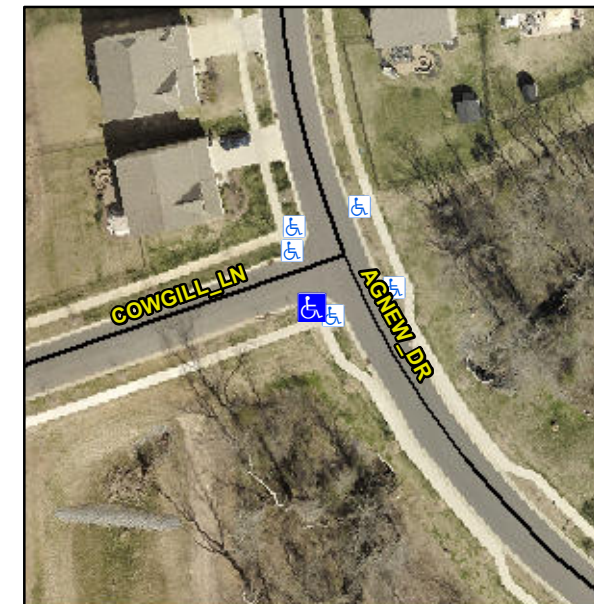
Compliance	Description	Data	Compliance	Description	Data
N/A	Ramp Length (in)	92.0	Yes	Ramp Slope (%)	5.7
Yes	Ramp Width (in)	48.0	Yes	Ramp XSlope (%)	0.0
N/A	Flare Type LT	Sloped	N/A	Flare Type RT	N/A
N/A	Flare Slope LT (%)	4.2	Yes	Flare Slope RT (%)	7.2
N/A	Flare Traversable LT?	Yes	N/A	Flare Traversable RT?	Yes
Yes	Landing Length (in)	60.0	Yes	DWS Provided?	Yes
Yes	Landing Width (in)	48.0	Yes	DWS Contrast?	Yes
Yes	Landing Slope (%)	0.2	Yes	DWS Length (in)	24.0
Yes	Landing X Slope (%)	0.2	Yes	DWS Full Width?	Yes
N/A	Landing Curb? (Y/N)	No	No	DWS Offset (in)	4.0
N/A	Shared Landing?	Yes			
Yes	Gutter Ponding?	No	Yes	Gutter Slope (%)	0.9
Yes	Gutter Lip Ht (in)	0.0	Yes	Gutter X Slope (%)	0.1
N/A	Painted X Walk1?	No	N/A	Painted X Walk2?	N/A
	X Walk 1 Direction	To N		X Walk 2 Direction	N/A
N/A	X Walk 1 Width (in)	N/A	N/A	X Walk 2 Width (in)	N/A
	X Walk 1 Slope (%)	1.9		X Walk 2 Slope (%)	N/A
	X Walk 1 X Slope (%)	0.7		X Walk 2 X Slope (%)	N/A

N/A	Ramp inside XWalk1?	N/A	N/A	Ramp inside XWalk2?	N/A
	Road Slope (%)	N/A	N/A	Clear Space?	Yes
	Road X Slope (%)	N/A	N/A	Clear Space to XWalk (in)	N/A
Yes	Any Obstructions?	No	Yes	Storm Grate/Utility Hazard?	No
	Obstruction Type			Storm Grate/Utility Type	
		N/A			N/A
			Yes	Surface Condition? (G/P)	Good

**Remove & Replace Detectable
Warning System.**

R305.2
