# Access Compliance Report

## Public Rights-of-Way

### (Curb Ramps)

| Intersection ID: 5236 | Main Street: COPPALA_DR | Cross Street: KORNIV_DR | Location: NE |

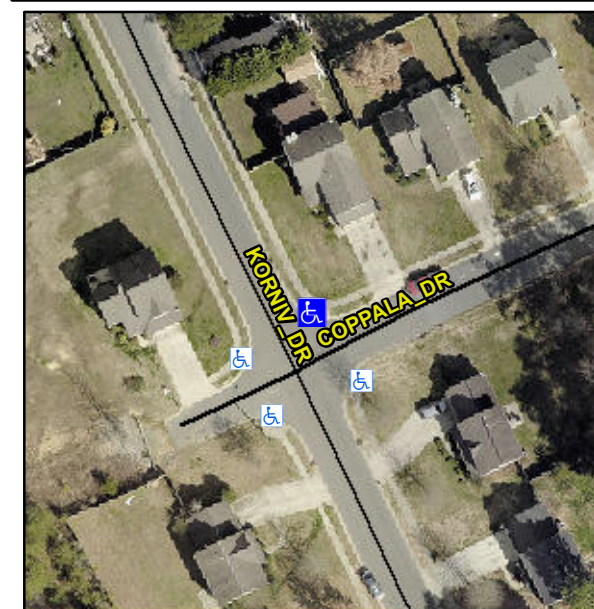
| ADA ID: 4146F8048804 | Ramp Type: PerpDiag | Initial Pass/Fail: Pass | Overall Compliance: No |
| Severity Score: 10.25 | | | |

| Compliance | Description | Data | Compliance | Description | Data |
|---|---|---|---|---|---|
| Yes | Ramp Width (in) | 57.0 | No | Ramp XSlope (%) | 3.2 |
| No | Landing Length (in) | 47.0 | No | DWS Provided? | No |
| No | Landing X Slope (%) | 3.9 | N/A | DWS Full Width? | No |
| Yes | Gutter Lip Ht (in) | 0.0 | No | Gutter X Slope (%) | 6.0 |

**Remove & Replace Curb Ramp With Two New Directional Ramps or Equivalent. Remove & Replace Gutter.**

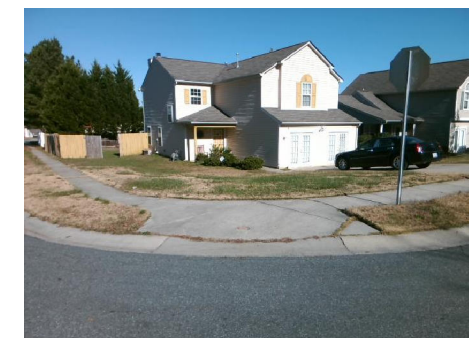
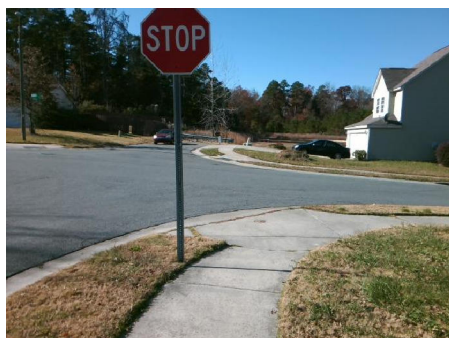
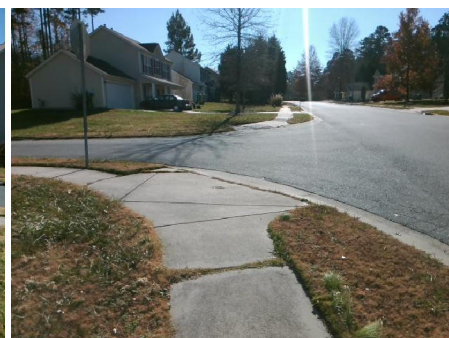
| Compliance | Description | Data | Compliance | Description | Data |
|---|---|---|---|---|---|
| | | Yes | | Surface Condition? (G/P) | Good |
