Access Compliance Report

Public Rights-of-Way

(Curb Ramps)

| ADA ID: 4154335BD095 | Ramp Type: Directional | Initial Pass/Fail: Fail | Overall Compliance: No | Severity Score: 25 |

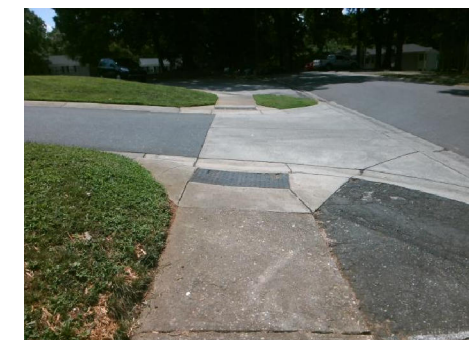
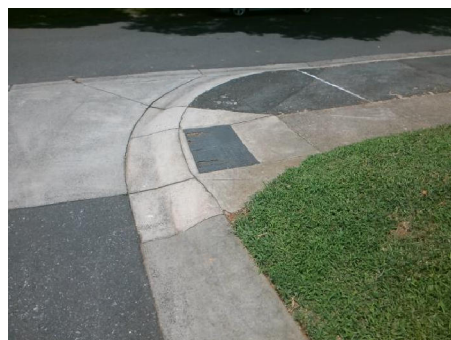
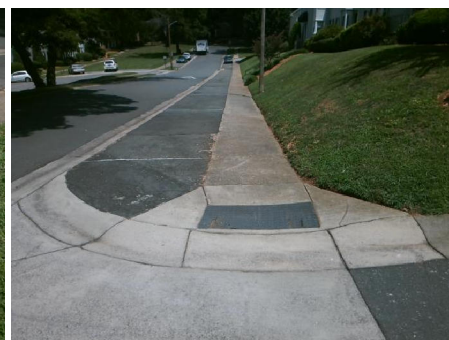
DAMAGED DWS

R304.5.3

| Compliance | Description | Data | Compliance | Description | Data |
|---|---|---|---|---|---|
| No | Ramp XSlope (%) | 14.4 | | | |

Remove & Replace Entire Ramp.
