Access Compliance Report

Public Rights-of-Way

(Curb Ramps)

Intersection ID: 18282	Main Street: RAMA_RD	Cross Street: RIVIERE_DR	Location: NW
ADA ID: 415659CE4D25	Ramp Type: PerpDiag	Initial Pass/Fail: Fail	Overall Compliance: No
Severity Score: 33.75			
Codes/Mitigation Info/Possible Solution		Field Measurements/Component Compliance

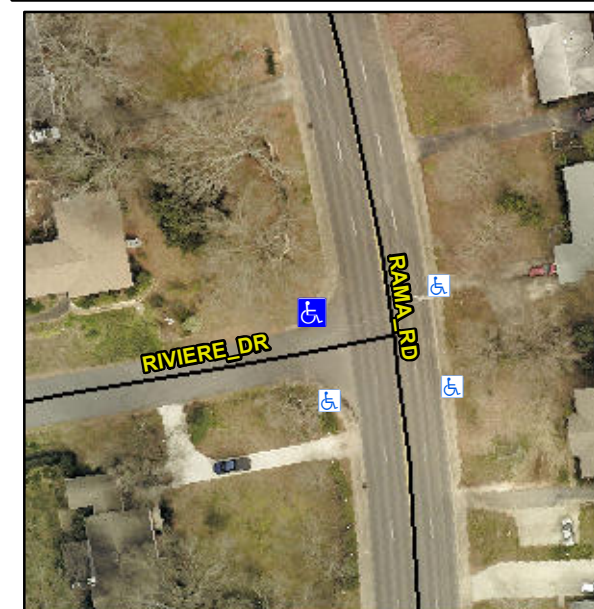
Not Found, R304.5.1, R304.2.2, R304.5.3

Compliance	Description	Data	Compliance	Description	Data
N/A	Ramp Length (in)	60.0	No	Ramp Slope (%)	9.8
No	Ramp Width (in)	44.0	No	Ramp XSlope (%)	5.3
N/A	Flare Type LT	N/A	N/A	Flare Type RT	N/A
N/A	Flare Slope LT (%)	N/A	N/A	Flare Slope RT (%)	N/A
N/A	Flare Traversable LT?	N/A	N/A	Flare Traversable RT?	N/A
N/A	Landing Length (in)	N/A	N/A	DWS Provided?	N/A
N/A	Landing Width (in)	N/A	N/A	DWS Contrast?	N/A
N/A	Landing Slope (%)	N/A	N/A	DWS Length (in)	N/A
N/A	Landing X Slope (%)	N/A	N/A	DWS Full Width?	N/A
N/A	Landing Curb? (Y/N)	N/A	N/A	DWS Offset (in)	N/A
N/A	Shared Landing?	N/A			
N/A	Gutter Ponding?	N/A	N/A	Gutter Slope (%)	N/A
N/A	Gutter Lip Ht (in)	N/A	N/A	Gutter X Slope (%)	N/A
N/A	Painted X Walk1?	No	N/A	Painted X Walk2?	No
	X Walk 1 Direction	To S		X Walk 2 Direction	To E
N/A	X Walk 1 Width (in)	N/A	N/A	X Walk 2 Width (in)	N/A
	X Walk 1 Slope (%)	3.5		X Walk 2 Slope (%)	0.3
	X Walk 1 X Slope (%)	3.5		X Walk 2 X Slope (%)	6.7

N/A	Ramp inside XWalk1?	N/A	N/A	Ramp inside XWalk2?	N/A
	Road Slope (%)	4.5	N/A	Clear Space?	N/A
	Road X Slope (%)	1.1	N/A	Clear Space to XWalk (in)	N/A
N/A	Any Obstructions?	N/A	N/A	Storm Grate/Utility Hazard?	N/A
	Obstruction Type			Storm Grate/Utility Type	
		N/A			N/A
			Yes	Surface Condition? (G/P)	Good

Possible Solutions:

Remove & Replace Curb Ramp With Two New Directional Ramps or Equivalent.
