Access Compliance Report

Public Rights-of-Way

(Curb Ramps)

Intersection ID: 14668	Main Street: BARRINGER_DR	Cross Street: MANCHESTER_DR	Location: NE
ADA ID: 4163EE12F892	Ramp Type: Perp	Initial Pass/Fail: Fail	Overall Compliance: No
Codes/Mitigation Info/Possible Solution		Field Measurements/Component Compliance	
Severity Score: 12.5

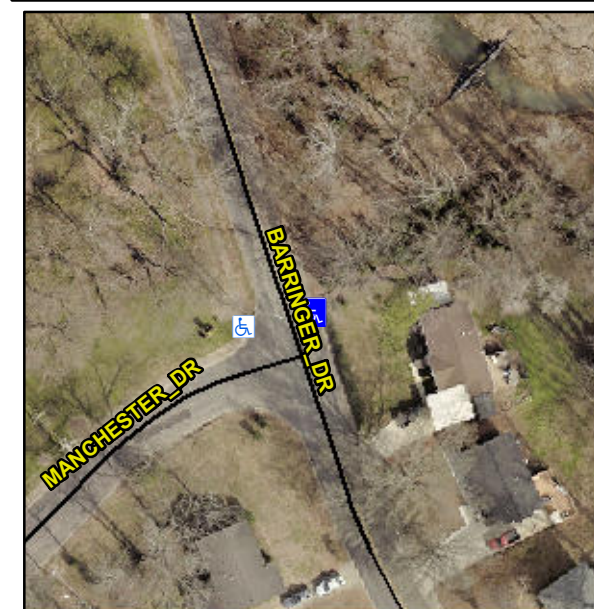
Not Found, R304.5.3

Compliance	Description	Data	Compliance	Description	Data
N/A	Ramp Length (in)	47.0	Yes	Ramp Slope (%)	5.1
Yes	Ramp Width (in)	48.0	No	Ramp XSlope (%)	6.9
N/A	Flare Type LT	N/A	N/A	Flare Type RT	N/A
N/A	Flare Slope LT (%)	N/A	N/A	Flare Slope RT (%)	N/A
N/A	Flare Traversable LT?	N/A	N/A	Flare Traversable RT?	N/A
N/A	Landing Length (in)	N/A	N/A	DWS Provided?	N/A
N/A	Landing Width (in)	N/A	N/A	DWS Contrast?	N/A
N/A	Landing Slope (%)	N/A	N/A	DWS Length (in)	N/A
N/A	Landing X Slope (%)	N/A	N/A	DWS Full Width?	N/A
N/A	Landing Curb? (Y/N)	N/A	N/A	DWS Offset (in)	N/A
N/A	Shared Landing?	N/A			
N/A	Gutter Ponding?	N/A	N/A	Gutter Slope (%)	N/A
N/A	Gutter Lip Ht (in)	N/A	N/A	Gutter X Slope (%)	N/A
N/A	Painted X Walk1?	No	N/A	Painted X Walk2?	N/A
	X Walk 1 Direction	To W		X Walk 2 Direction	N/A
N/A	X Walk 1 Width (in)	N/A	N/A	X Walk 2 Width (in)	N/A
	X Walk 1 Slope (%)	6.0		X Walk 2 Slope (%)	N/A
	X Walk 1 X Slope (%)	5.4		X Walk 2 X Slope (%)	N/A

Remove & Replace Entire Ramp.
