Access Compliance Report

Public Rights-of-Way

(Curb Ramps)

Intersection ID: 32296	Main Street: BAILEYWICK_RD	Cross Street: LISHA_LN	Location: SW
ADA ID: 41659E0B58C5	Ramp Type: PerpDiag	Initial Pass/Fail: Pass	Overall Compliance: No
			Severity Score: 10.25

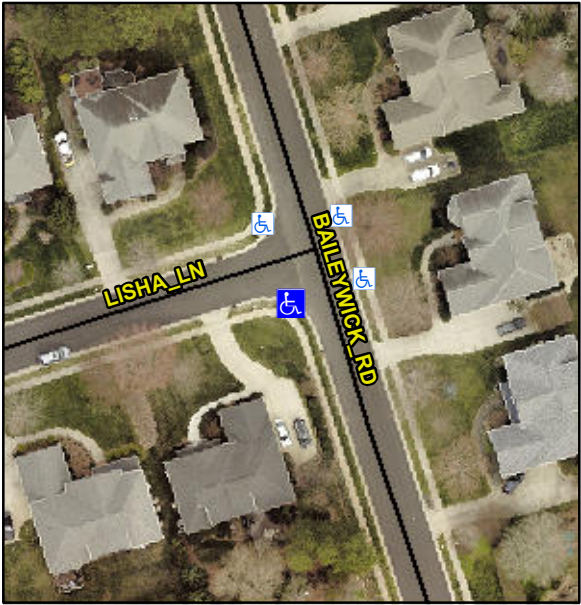
Possible Solutions:				
	Remove & Replace Curb Ramp With Two New Directional Ramps or Equivalent.				
	Surveyor Notes:				
	N/A				
	PROW/ADA:				
	Not Found, R304.5.3, R304.2.1, R305				
	Street 1 Name	BAILEYWICK RD			
	Stop Condition-Street 2	None			
	Street 2 Name	LISHA LN			
	Stop Condition-Street 1	StopSign			
	Total Cost:	\$ 3200.00			
Compliance	Description	Data	Compliance	Description	Data
N/A	Ramp Length (in)	62.0	Yes	Ramp Slope (%)	7.8
Yes	Ramp Width (in)	48.0	No	Ramp XSlope (%)	2.4
N/A	Flare Type LT	Sloped	N/A	Flare Type RT	N/A
N/A	Flare Slope LT (%)	7.7	Yes	Flare Slope RT (%)	4.2
N/A	Flare Traversable LT?	Yes	N/A	Flare Traversable RT?	Yes
No	Landing Length (in)	30.0	No	DWS Provided?	No
Yes	Landing Width (in)	48.0	N/A	DWS Contrast?	No
Yes	Landing Slope (%)	1.2	N/A	DWS Length (in)	N/A
No	Landing X Slope (%)	3.0	N/A	DWS Full Width?	No

N/A	Landing Curb? (Y/N)	No	N/A	DWS Offset (in)	N/A
N/A	Shared Landing?	No			
Yes	Gutter Ponding?	No	Yes	Gutter Slope (%)	2.5
Yes	Gutter Lip Ht (in)	0.0	Yes	Gutter X Slope (%)	0.4
N/A	Painted X Walk1?	No	N/A	Painted X Walk2?	No
	X Walk 1 Direction	To E		X Walk 2 Direction	To N
N/A	X Walk 1 Width (in)	N/A	N/A	X Walk 2 Width (in)	N/A
	X Walk 1 Slope (%)	2.4		X Walk 2 Slope (%)	1.1
	X Walk 1 X Slope (%)	0.7		X Walk 2 X Slope (%)	3.4
N/A	Ramp inside XWalk1?	N/A	N/A	Ramp inside XWalk2?	N/A
	Road Slope (%)	1.6	N/A	Clear Space?	Yes
	Road X Slope (%)	2.0	N/A	Clear Space to XWalk (in)	N/A
Yes	Any Obstructions?	No	Yes	Storm Grate/Utility Hazard?	No
	Obstruction Type			Storm Grate/Utility Type	
			N/A		N/A
			Yes	Surface Condition? (G/P)	Good
