# Access Compliance Report

## Public Rights-of-Way

| Intersection ID: 13283 | Main Street: SOUTHWOOD_AV | Cross Street: W_SUMMIT_AV | Location: S |
| ADA ID: 417D8D06CEE7 | Ramp Type: PerpDiag | Initial Pass/Fail: Fail | Overall Compliance: No |

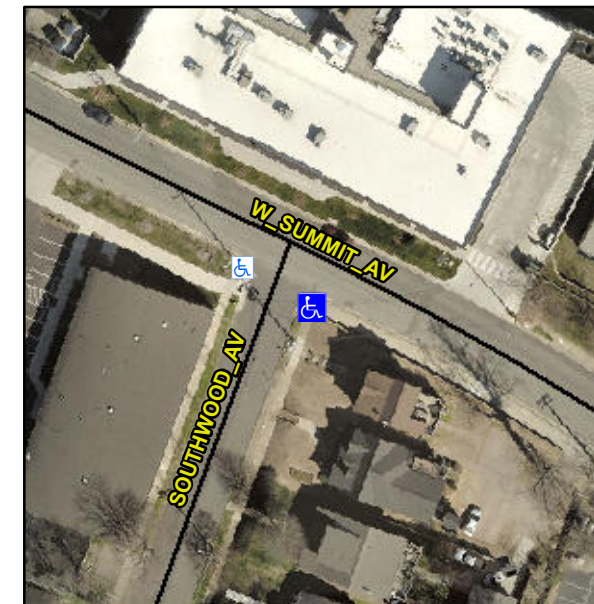
| Severity Score: 30 | | | |

**Not Found, R304.5.1, R304.5.3**

| Compliance | Description | Data | Compliance | Description | Data |
|---|---|---|---|---|---|
| N/A | Ramp Length (in) | 68.0 | Yes | Ramp Slope (%) | 5.1 |
| No | Ramp Width (in) | 34.0 | No | Ramp XSlope (%) | 5.2 |

**Remove & Replace Curb Ramp With Two New Directional Ramps or Equivalent.**

Total Cost: \$ 3200.00
