Access Compliance Report

Public Rights-of-Way

(Curb Ramps)

Intersection ID: 14235	Main Street: CAMDEN_RD	Cross Street: E_TREMONT_AV	Location: NE
ADA ID: 41816930C597	Ramp Type: Perp	Initial Pass/Fail: Fail	Overall Compliance: No
		Severity Score: 12.5

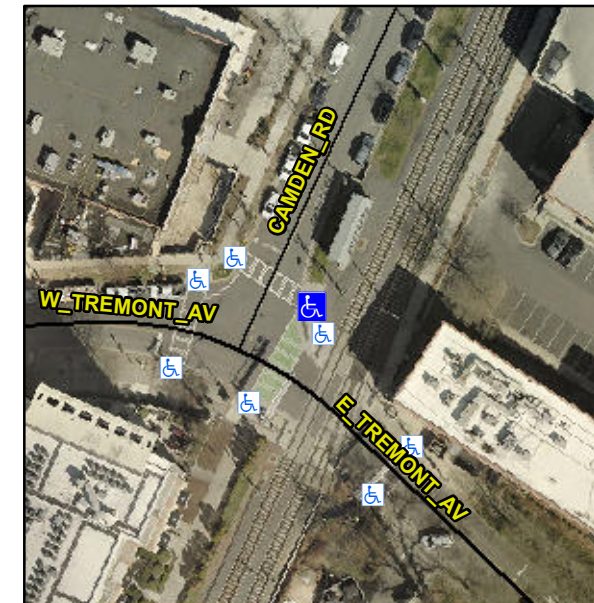
Compliance	Description	Data	Compliance	Description	Data
N/A	Ramp Length (in)	60.0	Yes	Ramp Slope (%)	7.0
Yes	Ramp Width (in)	59.0	No	Ramp XSlope (%)	6.6
N/A	Flare Type LT	N/A	N/A	Flare Type RT	N/A
N/A	Flare Slope LT (%)	N/A	N/A	Flare Slope RT (%)	N/A
N/A	Flare Traversable LT?	N/A	N/A	Flare Traversable RT?	N/A
N/A	Landing Length (in)	N/A	N/A	DWS Provided?	N/A
N/A	Landing Width (in)	N/A	N/A	DWS Contrast?	N/A
N/A	Landing Slope (%)	N/A	N/A	DWS Length (in)	N/A
N/A	Landing X Slope (%)	N/A	N/A	DWS Full Width?	N/A
N/A	Landing Curb? (Y/N)	N/A	N/A	DWS Offset (in)	N/A
N/A	Shared Landing?	N/A			
N/A	Gutter Ponding?	N/A	N/A	Gutter Slope (%)	N/A
N/A	Gutter Lip Ht (in)	N/A	N/A	Gutter X Slope (%)	N/A
N/A	Painted X Walk1?	Yes	N/A	Painted X Walk2?	N/A
	X Walk 1 Direction	To NW		X Walk 2 Direction	N/A
N/A	X Walk 1 Width (in)	112.0	N/A	X Walk 2 Width (in)	N/A
	X Walk 1 Slope (%)	3.1		X Walk 2 Slope (%)	N/A
	X Walk 1 X Slope (%)	6.3		X Walk 2 X Slope (%)	N/A

N/A	Ramp inside XWalk1?	Yes	N/A	Ramp inside XWalk2?	N/A
	Road Slope (%)	N/A	N/A	Clear Space?	N/A
	Road X Slope (%)	N/A	N/A	Clear Space to XWalk (in)	N/A
N/A	Any Obstructions?	N/A	N/A	Storm Grate/Utility Hazard?	N/A
	Obstruction Type			Storm Grate/Utility Type	
		N/A			N/A
		Yes		Surface Condition? (G/P)	Good

Remove & Replace Entire Ramp.
