# Access Compliance Report

## Public Rights-of-Way

### (Curb Ramps)

Intersection ID: 13156	Main Street: S_TRYON_ST	Cross Street: W_CARSON_BV	Location: SW
ADA ID: 4183D6D7D505	Ramp Type: PerpDiag	Initial Pass/Fail: Fail	Overall Compliance: No
		Severity Score: 22.5

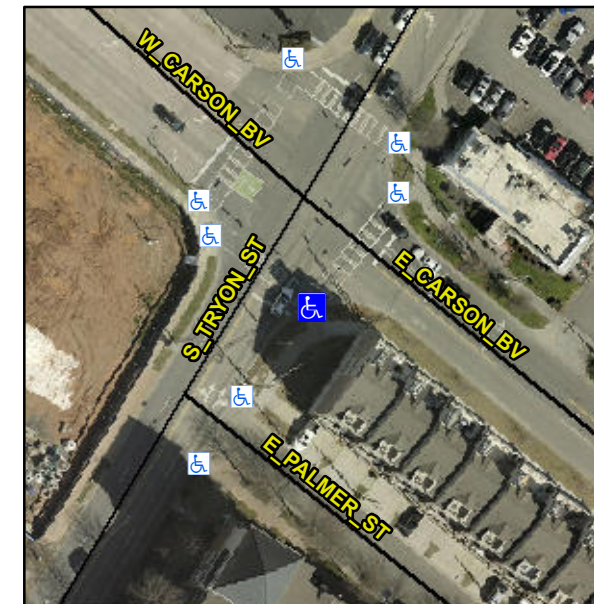
**Not Found, R304.5.1, R304.2.2, R304.5.3**

Compliance	Description	Data	Compliance	Description	Data
N/A	Ramp Length (in)	94.0	No	Ramp Slope (%)	8.6
No	Ramp Width (in)	45.0	No	Ramp XSlope (%)	2.2
N/A	Flare Type LT	N/A	N/A	Flare Type RT	N/A
N/A	Flare Slope LT (%)	N/A	N/A	Flare Slope RT (%)	N/A
N/A	Flare Traversable LT?	N/A	N/A	Flare Traversable RT?	N/A
N/A	Landing Length (in)	N/A	N/A	DWS Provided?	N/A
N/A	Landing Width (in)	N/A	N/A	DWS Contrast?	N/A
N/A	Landing Slope (%)	N/A	N/A	DWS Length (in)	N/A
N/A	Landing X Slope (%)	N/A	N/A	DWS Full Width?	N/A
N/A	Landing Curb? (Y/N)	N/A	N/A	DWS Offset (in)	N/A
N/A	Shared Landing?	N/A			
N/A	Gutter Ponding?	N/A	N/A	Gutter Slope (%)	N/A
N/A	Gutter Lip Ht (in)	N/A	N/A	Gutter X Slope (%)	N/A
N/A	Painted X Walk1?	Yes	N/A	Painted X Walk2?	Yes
	X Walk 1 Direction	To NE		X Walk 2 Direction	To NW
N/A	X Walk 1 Width (in)	112.0	N/A	X Walk 2 Width (in)	112.0
	X Walk 1 Slope (%)	3.6		X Walk 2 Slope (%)	2.4
	X Walk 1 X Slope (%)	5.2		X Walk 2 X Slope (%)	1.9

N/A	Ramp inside XWalk1?	Yes	N/A	Ramp inside XWalk2?	Yes
	Road Slope (%)	0.9	N/A	Clear Space?	N/A
	Road X Slope (%)	4.0	N/A	Clear Space to XWalk (in)	N/A
N/A	Any Obstructions?	N/A	N/A	Storm Grate/Utility Hazard?	N/A
	Obstruction Type			Storm Grate/Utility Type	
		N/A			N/A
		Yes		Surface Condition? (G/P)	Good

**Remove & Replace Curb Ramp With Two New Directional Ramps or Equivalent.**
