# Access Compliance Report

## Public Rights-of-Way

### (Curb Ramps)

Intersection ID: 15229	Main Street: CHARLOTTE_DR	Cross Street: IDEAL_WY	Location:	E
ADA ID: 418E17963C68	Ramp Type: PerpDiag	Initial Pass/Fail: Fail	Overall Compliance: No	Severity Score: 25
Codes/Mitigation Info/Possible Solution		Field Measurements/Component Compliance

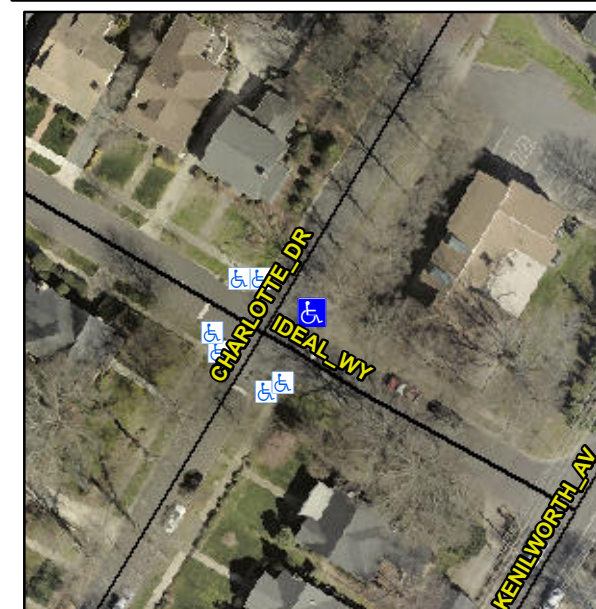
**Not Found, R304.5.3**

Compliance	Description	Data	Compliance	Description	Data
N/A	Ramp Length (in)	88.0	Yes	Ramp Slope (%)	6.4
Yes	Ramp Width (in)	48.0	No	Ramp XSlope (%)	7.6
N/A	Flare Type LT	N/A	N/A	Flare Type RT	N/A
N/A	Flare Slope LT (%)	N/A	N/A	Flare Slope RT (%)	N/A
N/A	Flare Traversable LT?	N/A	N/A	Flare Traversable RT?	N/A
N/A	Landing Length (in)	N/A	N/A	DWS Provided?	N/A
N/A	Landing Width (in)	N/A	N/A	DWS Contrast?	N/A
N/A	Landing Slope (%)	N/A	N/A	DWS Length (in)	N/A
N/A	Landing X Slope (%)	N/A	N/A	DWS Full Width?	N/A
N/A	Landing Curb? (Y/N)	N/A	N/A	DWS Offset (in)	N/A
N/A	Shared Landing?	N/A			
N/A	Gutter Ponding?	N/A	N/A	Gutter Slope (%)	N/A
N/A	Gutter Lip Ht (in)	N/A	N/A	Gutter X Slope (%)	N/A
N/A	Painted X Walk1?	No	N/A	Painted X Walk2?	No
	X Walk 1 Direction	To NW		X Walk 2 Direction	To SW
N/A	X Walk 1 Width (in)	N/A	N/A	X Walk 2 Width (in)	N/A
	X Walk 1 Slope (%)	3.8		X Walk 2 Slope (%)	10.3
	X Walk 1 X Slope (%)	6.5		X Walk 2 X Slope (%)	1.1

N/A	Ramp inside XWalk1?	N/A	N/A	Ramp inside XWalk2?	N/A
	Road Slope (%)	4.6	N/A	Clear Space?	N/A
	Road X Slope (%)	7.9	N/A	Clear Space to XWalk (in)	N/A
N/A	Any Obstructions?	N/A	N/A	Storm Grate/Utility Hazard?	N/A
	Obstruction Type			Storm Grate/Utility Type	
		N/A			N/A
			Yes	Surface Condition? (G/P)	Good

**Remove & Replace Curb Ramp With Two New Directional Ramps or Equivalent.**

Total Cost: \$ 3200.00
