Access Compliance Report Public Rights-of-Way (Curb Ramps)

Intersection ID: 54465 Main Street: RUPELL DR **Cross Street: COLLINGHAM DR** Location: NW ADA ID: 4191D5C0B53D Ramp Type: BlendTrans1 Initial Pass/Fail: Fail **Overall Compliance: No Severity Score:** 10

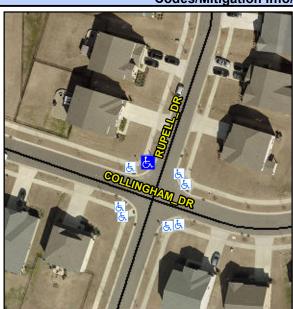
Field Measurements/Component Compilance						
	Compliance Description		Data	Compliance Description		Data
	N/A	Ramp Length (in)	96.0	Yes	BlendTrans Slope (%)	4.3
	No	Ramp Width (in)	47.0	No	BlendTrans XSlope (%)	3.0
	N/A	Flare Type LT	N/A	N/A	Flare Type RT	N/A
	N/A	Flare Slope LT (%)	N/A	N/A	Flare Slope RT (%)	N/A
	N/A	Flare Traversable LT?	N/A	N/A	Flare Traversable RT?	N/A
	N/A	Landing Length (in)	N/A	N/A	DWS Provided?	N/A
	N/A	Landing Width (in)	N/A	N/A	DWS Contrast?	N/A
	N/A	Landing Slope (%)	N/A	N/A	DWS Length (in)	N/A
	N/A	Landing X Slope (%)	N/A	N/A	DWS Full Width?	N/A
	N/A	Landing Curb? (Y/N)	N/A	N/A	DWS Offset (in)	N/A
	N/A	Shared Landing?	N/A			
	N/A	Gutter Ponding?	N/A	N/A	Gutter Slope (%)	N/A
	N/A	Gutter Lip Ht (in)	1.0	N/A	Gutter X Slope (%)	N/A
	N/A	Painted X Walk1?	No	N/A	Painted X Walk2?	N/A
		X Walk 1 Direction	To SE		X Walk 2 Direction	N/A
		X Walk 1 Width (in)	N/A		X Walk 2 Width (in)	N/A

X Walk 1 Slope (%)	3.4		X Walk 2 Slope (%)	N/A
		X Walk 1 X Slope (%)	0.3		X Walk 2 X Slope (%)	N/A
	N/A	Ramp inside XWalk1?	N/A	N/A	Ramp inside XWalk2?	N/A
		Road Slope (%)	0.3		Clear Space?	N/A
		Road X Slope (%)	3.4	N/A	Clear Space to XWalk (in)	N/A
	N/A	Any Obstructions?	N/A	N/A	Storm Grate/Utility Hazard?	N/A
		Obstruction Type		l	Storm Grate/Utility Type	
			N/A	l		N/A
				Yes	Surface Condition? (G/P)	Good
À		Time ()		No	Curb Slope (%)	15.2

RUPELL DR Street 1 Name Stop Condition-Street 1 StopSign Street 2 Name N/A Stop Condition-Street 2 N/A Possible Solutions: Remove & Replace Curb Ramp With Two New Directional Ramps or Equivalent. Surveyor Notes: N/A PROW/ADA: Not Found, R304.5.1, R304.5.3
