Access Compliance Report

Public Rights-of-Way

(Curb Ramps)

Intersection ID: 15055	Main Street: BUCHANAN_ST	Cross Street: SCOTT_AV	Location: W
ADA ID: 41961C6B2885	Ramp Type: Directional1	Initial Pass/Fail: Fail	Overall Compliance: No
Severity Score: 13.75			
Codes/Mitigation Info/Possible Solution		Field Measurements/Component Compliance

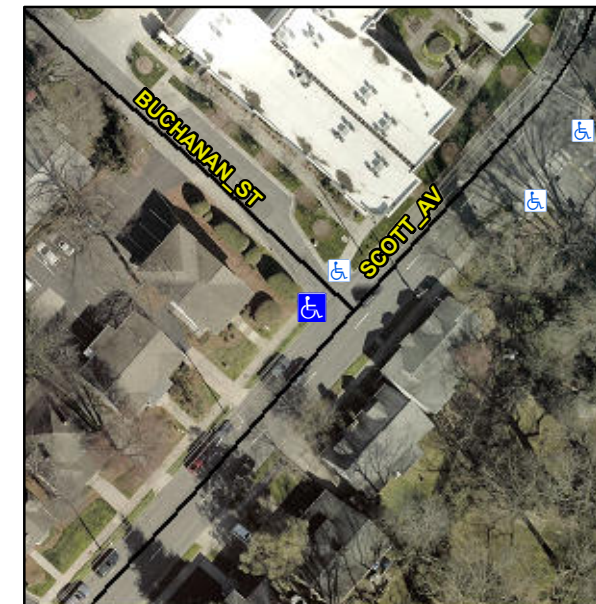
R304.2.2, R304.5.3

Compliance	Description	Data	Compliance	Description	Data
N/A	Ramp Length (in)	84.0	N/A	Grade Break?	N/A
Yes	Ramp Width (in)	48.0	N/A	Grade Break Slope (%)	0.0
No	Ramp Slope (%)	8.4	N/A	Grade Break XSlope (%)	0.0
No	Ramp XSlope (%)	2.1			
N/A	Flare Type LT	N/A	N/A	Flare Type RT	N/A
N/A	Flare Slope LT (%)	N/A	N/A	Flare Slope RT (%)	0.0
N/A	Flare Traversable LT?	N/A	N/A	Flare Traversable RT?	N/A
N/A	Landing Length (in)	0.0	N/A	DWS Provided?	N/A
N/A	Landing Width (in)	0.0	N/A	DWS Contrast?	N/A
N/A	Landing Slope (%)	0.0	N/A	DWS Length (in)	N/A
N/A	Landing X Slope (%)	0.0	N/A	DWS Full Width?	N/A
N/A	Landing Curb? (Y/N)	N/A	N/A	DWS Offset LT (in)	N/A
N/A	Shared Landing?	N/A	N/A	DWS Offset RT (in)	N/A
N/A	Gutter Ponding?	0.0	N/A	Gutter Slope (%)	N/A
N/A	Gutter Lip Ht (in)	0.0	N/A	Gutter X Slope (%)	N/A
N/A	Painted X Walk1?	No		Road Slope (%)	0.6
	X Walk 1 Direction	To NE		Road X Slope (%)	1.6
	X Walk 1 Width (in)	N/A		Clear Space?	N/A

X Walk 1 Slope (%)	0.6	N/A	Clear Space to XWalk (in)	N/A
	X Walk 1 X Slope (%)	1.6	N/A	Storm Grate/Utility Hazard?	N/A
N/A	Ramp inside XWalk1?	N/A		Storm Grate/Utility Type	
N/A	Any Obstructions?	N/A			N/A
	Obstruction Type		Yes	Surface Condition? (G/P)	Good
			N/A	Curb Slope (%)	8.8

Possible Solutions:

Remove & Replace Entire Ramp.
