Access Compliance Report

Public Rights-of-Way

(Curb Ramps)

Intersection ID: 7877	Main Street: PONDELLA_DR	Cross Street: SNOW_WHITE_LN	Location: SE
ADA ID: 419BB202E815	Ramp Type: Perp	Initial Pass/Fail: Fail	Overall Compliance: No
Codes/Mitigation Info/Possible Solution		Field Measurements/Component Compliance	
Severity Score: 21.25

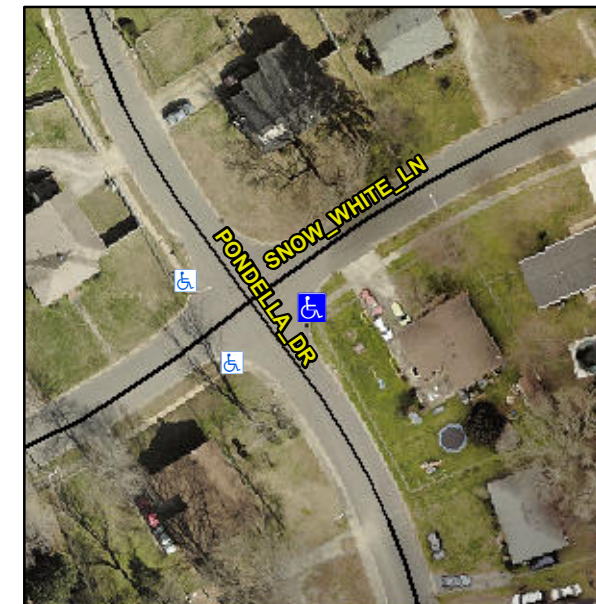
PROW/ADA:

Not Found, R304.5.1, R304.2.2

Compliance	Description	Data	Compliance	Description	Data
N/A	Ramp Length (in)	27.5	No	Ramp Slope (%)	9.2
No	Ramp Width (in)	45.0	Yes	Ramp XSlope (%)	0.8
N/A	Flare Type LT	N/A	N/A	Flare Type RT	N/A
N/A	Flare Slope LT (%)	N/A	N/A	Flare Slope RT (%)	N/A
N/A	Flare Traversable LT?	N/A	N/A	Flare Traversable RT?	N/A
N/A	Landing Length (in)	N/A	N/A	DWS Provided?	N/A
N/A	Landing Width (in)	N/A	N/A	DWS Contrast?	N/A
N/A	Landing Slope (%)	N/A	N/A	DWS Length (in)	N/A
N/A	Landing X Slope (%)	N/A	N/A	DWS Full Width?	N/A
N/A	Landing Curb? (Y/N)	N/A	N/A	DWS Offset (in)	N/A
N/A	Shared Landing?	N/A			
N/A	Gutter Ponding?	N/A	N/A	Gutter Slope (%)	N/A
N/A	Gutter Lip Ht (in)	N/A	N/A	Gutter X Slope (%)	N/A
N/A	Painted X Walk1?	No	N/A	Painted X Walk2?	N/A
	X Walk 1 Direction	To SW		X Walk 2 Direction	N/A
N/A	X Walk 1 Width (in)	N/A	N/A	X Walk 2 Width (in)	N/A
	X Walk 1 Slope (%)	3.6		X Walk 2 Slope (%)	N/A
	X Walk 1 X Slope (%)	3.0		X Walk 2 X Slope (%)	N/A

N/A	Ramp inside XWalk1?	N/A	N/A	Ramp inside XWalk2?	N/A
	Road Slope (%)	N/A	N/A	Clear Space?	N/A
	Road X Slope (%)	N/A	N/A	Clear Space to XWalk (in)	N/A
N/A	Any Obstructions?	N/A	N/A	Storm Grate/Utility Hazard?	N/A
	Obstruction Type			Storm Grate/Utility Type	
		N/A			N/A
			Yes	Surface Condition? (G/P)	Good

Possible Solutions:

Remove & Replace Entire Ramp.
