Access Compliance Report

Public Rights-of-Way

(Curb Ramps)

Intersection ID: N/A	Main Street: PROVIDENCE_RD	Cross Street: N/A	Location: SW
ADA ID: 41A410A26C00	Ramp Type: Perp	Initial Pass/Fail: Fail	Overall Compliance: No
Severity Score: 18.75			
Codes/Mitigation Info/Possible Solution		Field Measurements/Component Compliance

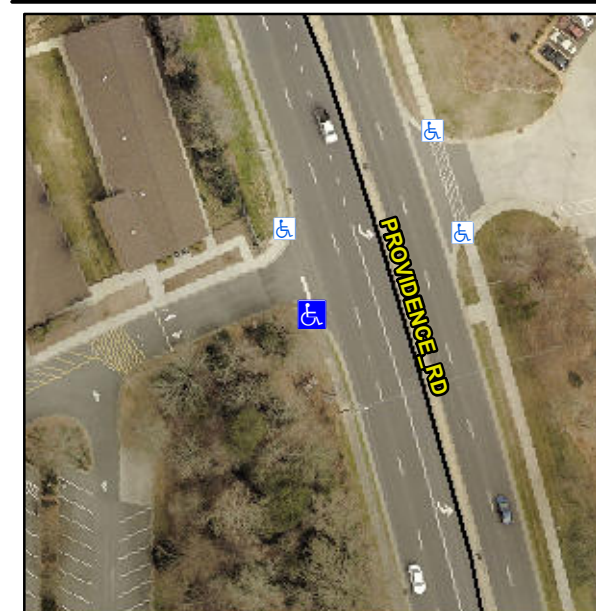
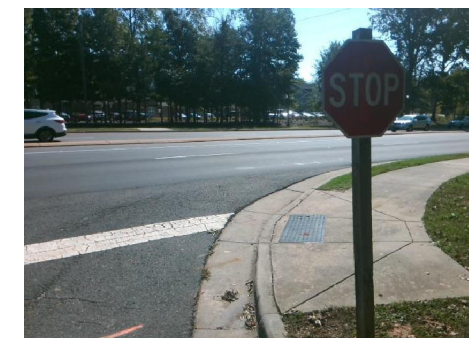
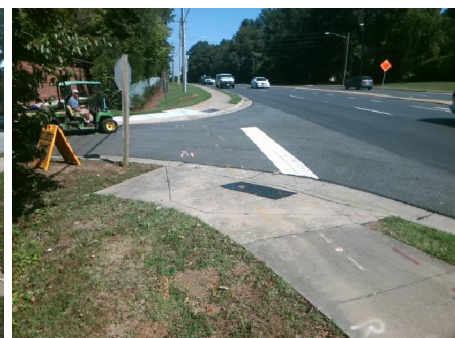
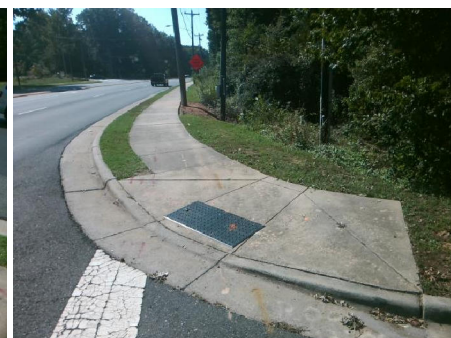
Compliance	Description	Data	Compliance	Description	Data
N/A	Ramp Length (in)	85.5	Yes	Ramp Slope (%)	5.5
No	Ramp Width (in)	32.0	No	Ramp XSlope (%)	4.6
N/A	Flare Type LT	N/A	N/A	Flare Type RT	N/A
N/A	Flare Slope LT (%)	N/A	N/A	Flare Slope RT (%)	N/A
N/A	Flare Traversable LT?	N/A	N/A	Flare Traversable RT?	N/A
N/A	Landing Length (in)	N/A	N/A	DWS Provided?	N/A
N/A	Landing Width (in)	N/A	N/A	DWS Contrast?	N/A
N/A	Landing Slope (%)	N/A	N/A	DWS Length (in)	N/A
N/A	Landing X Slope (%)	N/A	N/A	DWS Full Width?	N/A
N/A	Landing Curb? (Y/N)	N/A	N/A	DWS Offset (in)	N/A
N/A	Shared Landing?	N/A			
N/A	Gutter Ponding?	N/A	N/A	Gutter Slope (%)	N/A
N/A	Gutter Lip Ht (in)	N/A	N/A	Gutter X Slope (%)	N/A
N/A	Painted X Walk1?	No	N/A	Painted X Walk2?	N/A
	X Walk 1 Direction	To N		X Walk 2 Direction	N/A
N/A	X Walk 1 Width (in)	N/A	N/A	X Walk 2 Width (in)	N/A
	X Walk 1 Slope (%)	1.7		X Walk 2 Slope (%)	N/A
	X Walk 1 X Slope (%)	8.9		X Walk 2 X Slope (%)	N/A

N/A	Ramp inside XWalk1?	N/A	N/A	Ramp inside XWalk2?	N/A
	Road Slope (%)	N/A	N/A	Clear Space?	N/A
	Road X Slope (%)	N/A	N/A	Clear Space to XWalk (in)	N/A
N/A	Any Obstructions?	N/A	N/A	Storm Grate/Utility Hazard?	N/A
	Obstruction Type			Storm Grate/Utility Type	
		N/A			N/A
		Yes		Surface Condition? (G/P)	Good

Possible Solutions:

Remove & Replace Entire Ramp.

R304.5.1, R304.5.3
