# Access Compliance Report

## Public Rights-of-Way

### (Curb Ramps)

Intersection ID: 47300	Main Street: LELA_AV	Cross Street: HURSTON_CR	Location: S
ADA ID: 41ACF8A03CC3	Ramp Type: BlendTrans1	Initial Pass/Fail: Fail	Overall Compliance: No
			Severity Score: 21.25

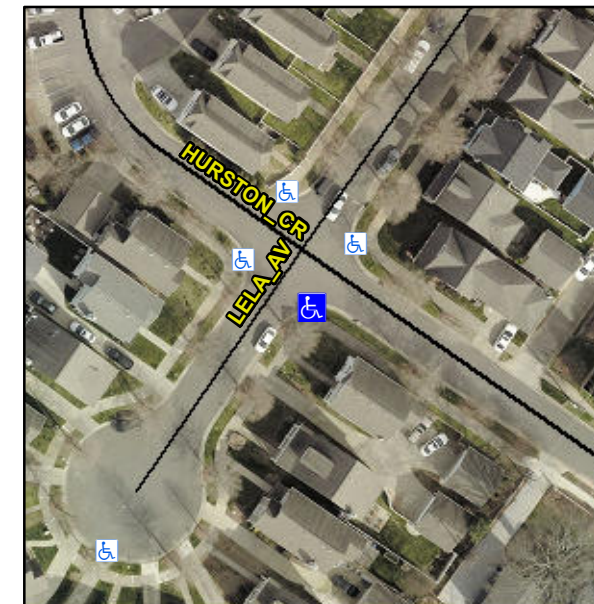
#### Field Measurements/Component Compliance

Compliance	Description	Data	Compliance	Description	Data
N/A	Ramp Length (in)	68.5	Yes	BlendTrans Slope (%)	2.3
No	Ramp Width (in)	39.0	No	BlendTrans XSlope (%)	5.5
N/A	Flare Type LT	N/A	N/A	Flare Type RT	N/A
N/A	Flare Slope LT (%)	N/A	N/A	Flare Slope RT (%)	N/A
N/A	Flare Traversable LT?	N/A	N/A	Flare Traversable RT?	N/A
N/A	Landing Length (in)	N/A	N/A	DWS Provided?	N/A
N/A	Landing Width (in)	N/A	N/A	DWS Contrast?	N/A
N/A	Landing Slope (%)	N/A	N/A	DWS Length (in)	N/A
N/A	Landing X Slope (%)	N/A	N/A	DWS Full Width?	N/A
N/A	Landing Curb? (Y/N)	N/A	N/A	DWS Offset (in)	N/A
N/A	Shared Landing?	N/A			
N/A	Gutter Ponding?	N/A	N/A	Gutter Slope (%)	N/A
N/A	Gutter Lip Ht (in)	N/A	N/A	Gutter X Slope (%)	N/A
N/A	Painted X Walk1?	No	N/A	Painted X Walk2?	No
	X Walk 1 Direction	To NE		X Walk 2 Direction	To NW
	X Walk 1 Width (in)	N/A		X Walk 2 Width (in)	N/A
	X Walk 1 Slope (%)	0.6		X Walk 2 Slope (%)	4.6
	X Walk 1 X Slope (%)	3.5		X Walk 2 X Slope (%)	1.6

N/A	Ramp inside XWalk1?	N/A	N/A	Ramp inside XWalk2?	N/A
	Road Slope (%)	4.7		Clear Space?	N/A
	Road X Slope (%)	1.2	N/A	Clear Space to XWalk (in)	N/A
N/A	Any Obstructions?	N/A	N/A	Storm Grate/Utility Hazard?	N/A
	Obstruction Type			Storm Grate/Utility Type	
		N/A			N/A
			Yes	Surface Condition? (G/P)	Good
			N/A	Curb Slope (%)	2.8

**Remove & Replace Curb Ramp With Two New Directional Ramps or Equivalent.**

**R304.5.1, R304.5.3**
