Access Compliance Report

Public Rights-of-Way

(Curb Ramps)

Intersection ID: N/A	Main Street: VIZCAYA_CT	Cross Street: BISCAY_DR	Location: SE
ADA ID: 41B9226DBE7F	Ramp Type: Perp	Initial Pass/Fail: Fail	Overall Compliance: No
Severity Score: 8.75			
Codes/Mitigation Info/Possible Solution		Field Measurements/Component Compliance

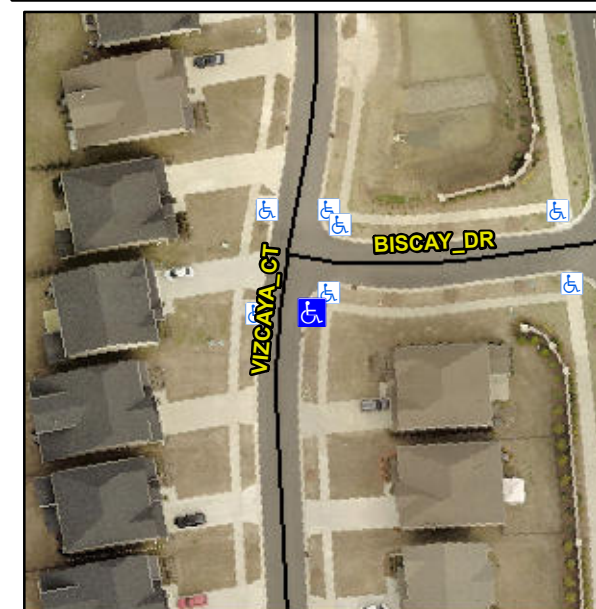
R304.5.1

Compliance	Description	Data	Compliance	Description	Data
N/A	Ramp Length (in)	93.0	Yes	Ramp Slope (%)	5.4
No	Ramp Width (in)	45.0	Yes	Ramp XSlope (%)	1.4
N/A	Flare Type LT	N/A	N/A	Flare Type RT	N/A
N/A	Flare Slope LT (%)	N/A	N/A	Flare Slope RT (%)	N/A
N/A	Flare Traversable LT?	N/A	N/A	Flare Traversable RT?	N/A
N/A	Landing Length (in)	N/A	N/A	DWS Provided?	N/A
N/A	Landing Width (in)	N/A	N/A	DWS Contrast?	N/A
N/A	Landing Slope (%)	N/A	N/A	DWS Length (in)	N/A
N/A	Landing X Slope (%)	N/A	N/A	DWS Full Width?	N/A
N/A	Landing Curb? (Y/N)	N/A	N/A	DWS Offset (in)	N/A
N/A	Shared Landing?	N/A			
N/A	Gutter Ponding?	N/A	N/A	Gutter Slope (%)	N/A
N/A	Gutter Lip Ht (in)	N/A	N/A	Gutter X Slope (%)	N/A
N/A	Painted X Walk1?	No	N/A	Painted X Walk2?	N/A
	X Walk 1 Direction	To W		X Walk 2 Direction	N/A
N/A	X Walk 1 Width (in)	N/A	N/A	X Walk 2 Width (in)	N/A
	X Walk 1 Slope (%)	3.9		X Walk 2 Slope (%)	N/A
	X Walk 1 X Slope (%)	0.8		X Walk 2 X Slope (%)	N/A

Possible Solutions:

Remove & Replace Entire Ramp.

Total Cost: \$ 1850.00
