Intersection ID: 6784	Main Street: ROUNDEAF_DR	Cross Street: WINGDALE_DR	Location:	NE
ADA ID: 41BAF74C06D7	Ramp Type: Perp	Initial Pass/Fail: Fail	Overall Compliance: No	Severity Score: 35

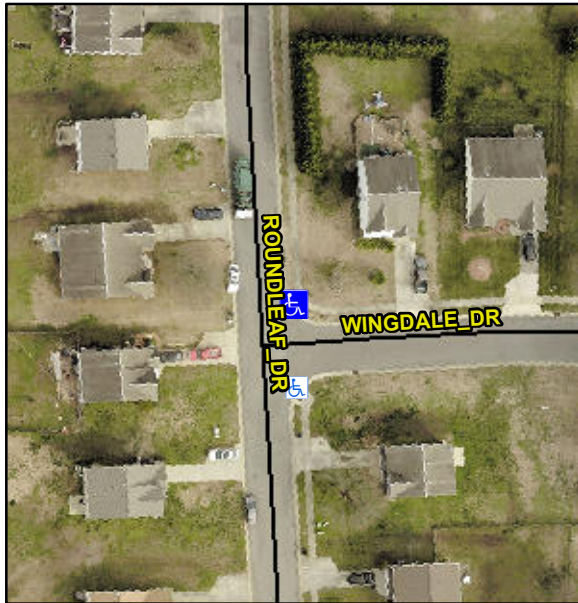
**Not Found, R304.5.1, R304.2.2,
R304.5.3**

Possible Solutions:			Compliance	Description	Data	Compliance	Description	Data		
Remove & Replace Entire Ramp.			N/A	Ramp Length (in)	49.0	No	Ramp Slope (%)	13.2		
			No	Ramp Width (in)	36.5	No	Ramp XSlope (%)	4.5		
			N/A	Flare Type LT	N/A	N/A	Flare Type RT	N/A		
			N/A	Flare Slope LT (%)	N/A	N/A	Flare Slope RT (%)	N/A		
			N/A	Flare Traversable LT?	N/A	N/A	Flare Traversable RT?	N/A		
			N/A	Landing Length (in)	N/A	N/A	DWS Provided?	N/A		
			N/A	Landing Width (in)	N/A	N/A	DWS Contrast?	N/A		
			N/A	Landing Slope (%)	N/A	N/A	DWS Length (in)	N/A		
			N/A	Landing X Slope (%)	N/A	N/A	DWS Full Width?	N/A		
			N/A	Landing Curb? (Y/N)	N/A	N/A	DWS Offset (in)	N/A		
Surveyor Notes: N/A			N/A	Shared Landing?	N/A					
			N/A	Gutter Ponding?	N/A	N/A	Gutter Slope (%)	N/A		
			N/A	Gutter Lip Ht (in)	N/A	N/A	Gutter X Slope (%)	N/A		
			N/A	Painted X Walk1?	No	N/A	Painted X Walk2?	N/A		
				X Walk 1 Direction	To S		X Walk 2 Direction	N/A

N/A	X Walk 1 Width (in)	N/A	N/A	X Walk 2 Width (in)	N/A		
				X Walk 1 Slope (%)	4.0		X Walk 2 Slope (%)	N/A		
				X Walk 1 X Slope (%)	1.3		X Walk 2 X Slope (%)	N/A		
			N/A	Ramp inside XWalk1?	N/A	N/A	Ramp inside XWalk2?	N/A		
				Road Slope (%)	N/A	N/A	Clear Space?	N/A		
PROW/ADA: Not Found, R304.5.1, R304.2.2, R304.5.3				Road X Slope (%)	N/A	N/A	Clear Space to XWalk (in)	N/A		
			N/A	Any Obstructions?	N/A	N/A	Storm Grate/Utility Hazard?	N/A		
				Obstruction Type			Storm Grate/Utility Type			
					N/A			N/A		
						Yes	Surface Condition? (G/P)	Good		
			Total Cost:			\$	1850.00

Remove & Replace Entire Ramp.
