Access Compliance Report

Public Rights-of-Way

(Curb Ramps)

Intersection ID: 4006	Main Street: STATESVILLE_RD	Cross Street: TRANSPORT_DR	Location: NW
ADA ID: 41BC97D3824B	Ramp Type: Perp	Initial Pass/Fail: Fail	Overall Compliance: No
Severity Score: 25			
Codes/Mitigation Info/Possible Solution		Field Measurements/Component Compliance

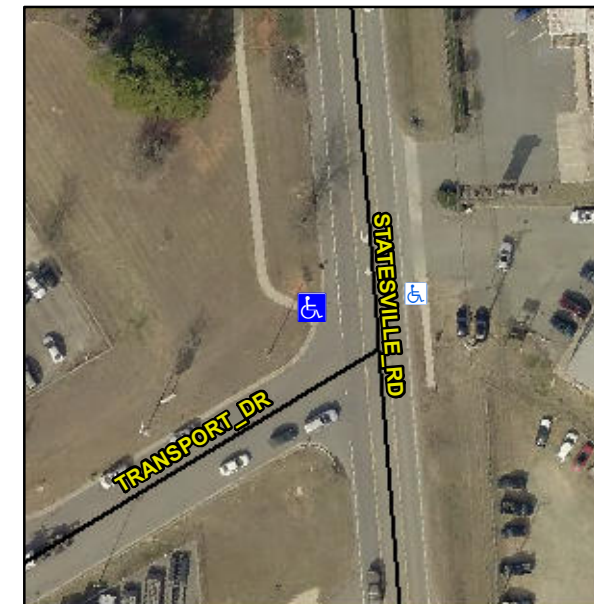
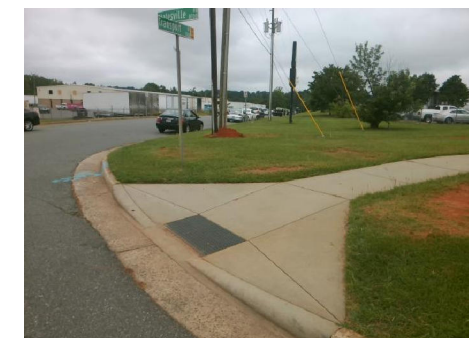
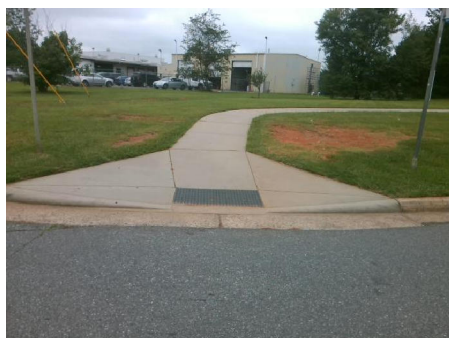
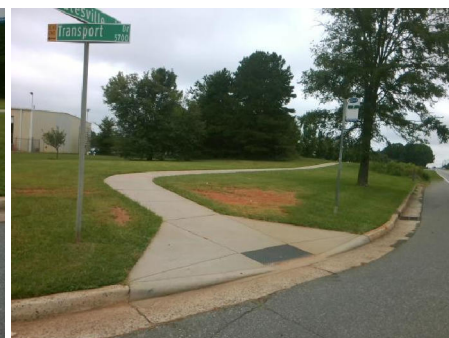
Compliance	Description	Data	Compliance	Description	Data
N/A	Ramp Length (in)	101.0	No	Ramp Slope (%)	12.6
Yes	Ramp Width (in)	48.0	Yes	Ramp XSlope (%)	0.5
N/A	Flare Type LT	N/A	N/A	Flare Type RT	N/A
N/A	Flare Slope LT (%)	N/A	N/A	Flare Slope RT (%)	N/A
N/A	Flare Traversable LT?	N/A	N/A	Flare Traversable RT?	N/A
N/A	Landing Length (in)	N/A	N/A	DWS Provided?	N/A
N/A	Landing Width (in)	N/A	N/A	DWS Contrast?	N/A
N/A	Landing Slope (%)	N/A	N/A	DWS Length (in)	N/A
N/A	Landing X Slope (%)	N/A	N/A	DWS Full Width?	N/A
N/A	Landing Curb? (Y/N)	N/A	N/A	DWS Offset (in)	N/A
N/A	Shared Landing?	N/A			
N/A	Gutter Ponding?	N/A	N/A	Gutter Slope (%)	N/A
N/A	Gutter Lip Ht (in)	N/A	N/A	Gutter X Slope (%)	N/A
N/A	Painted X Walk1?	No	N/A	Painted X Walk2?	N/A
	X Walk 1 Direction	To E		X Walk 2 Direction	N/A
N/A	X Walk 1 Width (in)	N/A	N/A	X Walk 2 Width (in)	N/A
	X Walk 1 Slope (%)	6.0		X Walk 2 Slope (%)	N/A
	X Walk 1 X Slope (%)	2.4		X Walk 2 X Slope (%)	N/A

N/A	Ramp inside XWalk1?	N/A	N/A	Ramp inside XWalk2?	N/A
	Road Slope (%)	N/A	N/A	Clear Space?	N/A
	Road X Slope (%)	N/A	N/A	Clear Space to XWalk (in)	N/A
N/A	Any Obstructions?	N/A	N/A	Storm Grate/Utility Hazard?	N/A
	Obstruction Type			Storm Grate/Utility Type	
		N/A			N/A
			Yes	Surface Condition? (G/P)	Good

Possible Solutions:

Remove & Replace Entire Ramp.

R304.2.2
