# Access Compliance Report

## Public Rights-of-Way

### (Curb Ramps)

| Intersection ID: 51821 | Main Street: WILLOW_OAK_RD | Cross Street: WILLOW_MANOR_RD | Location: NE |

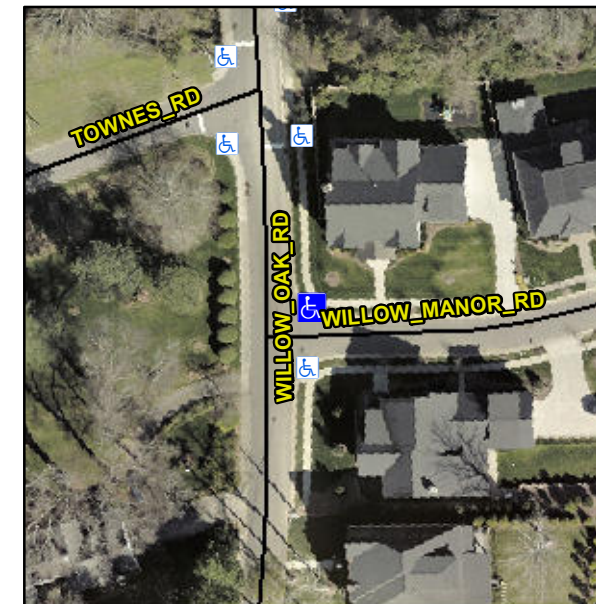
**Not Found, R304.5.3, R304.2.1, R305.2, R302.7.2, R304.5.4**

| Compliance | Description | Data | Compliance | Description | Data |
|---|---|---|---|---|---|
| Yes | Ramp Width (in) | 48.0 | No | Ramp XSlope (%) | 4.7 |
| No | Landing Length (in) | 47.0 | Yes | DWS Provided? | Yes |
| N/A | Landing Curb? (Y/N) | No | No | DWS Offset (in) | 5.5 |
| Yes | Gutter Ponding? | No | No | Gutter Slope (%) | 9.0 |
| No | Gutter Lip Ht (in) | 0.5 | Yes | Gutter X Slope (%) | 0.9 |

**Remove & Replace Curb Ramp With Two New Directional Ramps or Equivalent. Remove & Replace Gutter.**
