Access Compliance Report

Public Rights-of-Way

(Curb Ramps)

| Intersection ID: 47979 | Main Street: SPRINGS_MILL_RD | Cross Street: RAFFIA_RD | Location: SW |

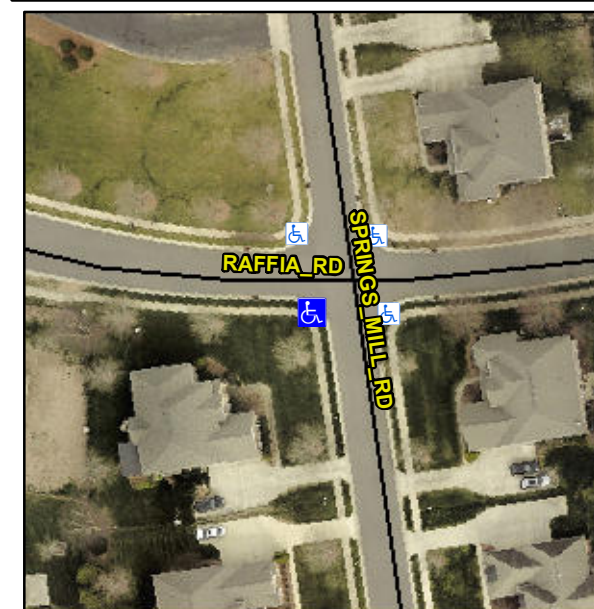
| ADA ID: 41C97AAAC8C9 | Ramp Type: PerpDiag | Initial Pass/Fail: Fail | Overall Compliance: No |
| Severity Score: 8.75 | | | |

R304.5.1

| Compliance | Description | Data | Compliance | Description | Data |
|---|---|---|---|---|---|
| No | Ramp Width (in) | 46.5 | Yes | Ramp XSlope (%) | 1.6 |

Remove & Replace Curb Ramp With Two New Directional Ramps or Equivalent.
