## **Access Compliance Report Public Rights-of-Way** (Curb Ramps)

Intersection ID: 15273 Main Street: E\_INDEPENDENCE\_BV Cross Street: NORLAND\_RD Location: NE **Overall Compliance: No ADA ID: 41CA54DD99F7** Ramp Type: Perp Initial Pass/Fail: Fail Severity Score: 21.25

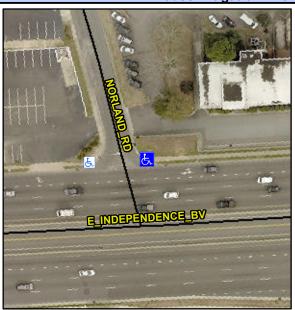
Possible Solutions:	Comp	liance Description	Data	Compl	iance Description	Data
Remove & Replace Entire Ramp.	N/A	Ramp Length (in)	45.0	No	Ramp Slope (%)	11.1
	No	Ramp Width (in)	40.5	Yes	Ramp XSlope (%)	0.2
	N/A	Flare Type LT	N/A	N/A	Flare Type RT	N/A
	N/A	Flare Slope LT (%)	N/A	N/A	Flare Slope RT (%)	N/A
	N/A	Flare Traversable LT?	N/A	N/A	Flare Traversable RT?	N/A
	N/A	Landing Length (in)	N/A	N/A	DWS Provided?	N/A
Surveyor Notes:	N/A	Landing Width (in)	N/A	N/A	DWS Contrast?	N/A
N/A	N/A	Landing Slope (%)	N/A	N/A	DWS Length (in)	N/A
	N/A	Landing X Slope (%)	N/A	N/A	DWS Full Width?	N/A
	N/A	Landing Curb? (Y/N)	N/A	N/A	DWS Offset (in)	N/A
	N/A	Shared Landing?	N/A			
PROW/ADA:	N/A	Gutter Ponding?	N/A	N/A	Gutter Slope (%)	N/A
Not Found, R304.5.1, R304.2.2	N/A	Gutter Lip Ht (in)	N/A	N/A	Gutter X Slope (%)	N/A
	N/A	Painted X Walk1?	No	N/A	Painted X Walk2?	N/A
		X Walk 1 Direction	To W		X Walk 2 Direction	N/A
	N/A	X Walk 1 Width (in)	N/A	N/A	X Walk 2 Width (in)	N/A

X Walk 1 Slope (%)	0.2		X Walk 2 Slope (%)	N/A
		X Walk 1 X Slope (%)	1.8		X Walk 2 X Slope (%)	N/A
	N/A	Ramp inside XWalk1?	N/A	N/A	Ramp inside XWalk2?	N/A
		Road Slope (%)	N/A	N/A	Clear Space?	N/A
		Road X Slope (%)	N/A	N/A	Clear Space to XWalk (in)	N/A
	N/A	Any Obstructions?	N/A	N/A	Storm Grate/Utility Hazard?	N/A
Total Cost: \$ 1850.00		Obstruction Type			Storm Grate/Utility Type	
			N/A			N/A
				Yes	Surface Condition? (G/P)	Good
