# Access Compliance Report

## Public Rights-of-Way

### (Curb Ramps)

Intersection ID: N/A	Main Street: GANNON_DR	Cross Street: BEREWICK_TOWN_CENTER	Location: SE
ADA ID: 41CC900D5C39	Ramp Type: Perp	Initial Pass/Fail: Pass	Overall Compliance: Yes
Severity Score: 0			
Codes/Mitigation Info/Possible Solution		Field Measurements/Component Compliance

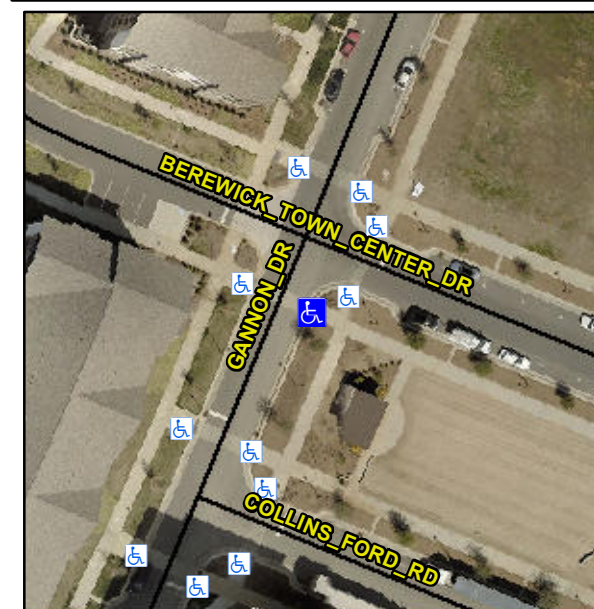
Compliance	Description	Data	Compliance	Description	Data
N/A	Ramp Length (in)	172.0	Yes	Ramp Slope (%)	7.4
Yes	Ramp Width (in)	96.0	Yes	Ramp XSlope (%)	0.3
Yes	Flare Type L	Curbed_NoWalkSurface	Yes	Flare Type RT	N/A
Yes	Flare Slope LT (%)	N/A	N/A	Flare Slope RT (%)	N/A
N/A	Flare Traversable LT?	No	N/A	Flare Traversable RT?	No
Yes	Landing Length (in)	80.0	Yes	DWS Provided?	Yes
Yes	Landing Width (in)	96.0	Yes	DWS Contrast?	Yes
Yes	Landing Slope (%)	1.1	Yes	DWS Length (in)	24.0
Yes	Landing X Slope (%)	1.5	Yes	DWS Full Width?	Yes
N/A	Landing Curb? (Y/N)	No	Yes	DWS Offset (in)	0.0
N/A	Shared Landing?	Yes			
Yes	Gutter Ponding?	No	Yes	Gutter Slope (%)	1.8
Yes	Gutter Lip Ht (in)	0.0	Yes	Gutter X Slope (%)	1.3
N/A	Painted X Walk1?	Yes	N/A	Painted X Walk2?	N/A
	X Walk 1 Direction	To NW		X Walk 2 Direction	N/A
N/A	X Walk 1 Width (in)	98.0	N/A	X Walk 2 Width (in)	N/A
	X Walk 1 Slope (%)	1.2		X Walk 2 Slope (%)	N/A
	X Walk 1 X Slope (%)	1.2		X Walk 2 X Slope (%)	N/A

Yes	Ramp inside XWalk1?	Yes	N/A	Ramp inside XWalk2?	N/A
	Road Slope (%)	N/A	N/A	Clear Space?	Yes
	Road X Slope (%)	N/A	N/A	Clear Space to XWalk (in)	N/A
Yes	Any Obstructions?	No	Yes	Storm Grate/Utility Hazard?	No
	Obstruction Type			Storm Grate/Utility Type	
		N/A			N/A
			Yes	Surface Condition? (G/P)	Good

Possible Solutions:

N/A
