# Access Compliance Report

## Public Rights-of-Way

### (Curb Ramps)

Intersection ID: 27197	Main Street: BALLANTYNE COMMONS PY	Cross Street: CRESTWOOD DR	Location: SW
ADA ID: 41E25F2055F3	Ramp Type: Perp	Initial Pass/Fail: Fail	Overall Compliance: No
		Severity Score: 22.5	
Codes/Mitigation Info/Possible Solution		Field Measurements/Component Compliance

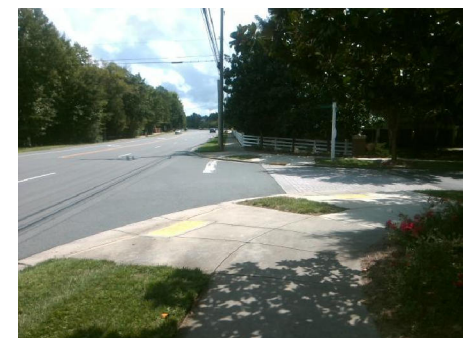
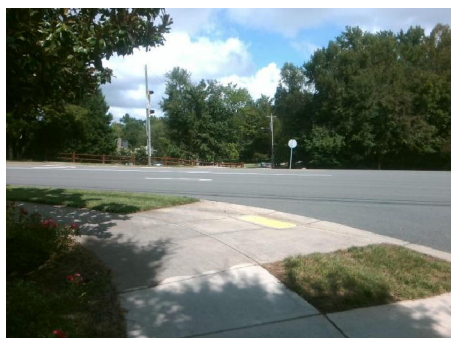
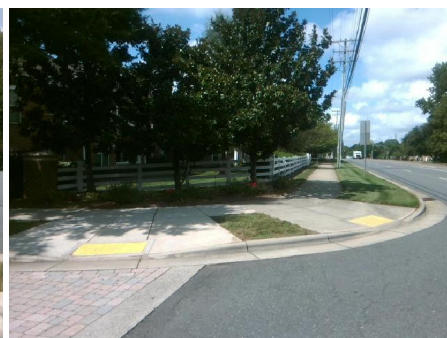
**R304.5.1, R304.2.2, R304.5.3**

Compliance	Description	Data	Compliance	Description	Data
N/A	Ramp Length (in)	<b>91.0</b>	No	Ramp Slope (%)	<b>9.3</b>
No	Ramp Width (in)	<b>39.0</b>	No	Ramp XSlope (%)	<b>2.7</b>
N/A	Flare Type LT	<b>N/A</b>	N/A	Flare Type RT	<b>N/A</b>
N/A	Flare Slope LT (%)	<b>N/A</b>	N/A	Flare Slope RT (%)	<b>N/A</b>
N/A	Flare Traversable LT?	<b>N/A</b>	N/A	Flare Traversable RT?	<b>N/A</b>
N/A	Landing Length (in)	<b>N/A</b>	N/A	DWS Provided?	<b>N/A</b>
N/A	Landing Width (in)	<b>N/A</b>	N/A	DWS Contrast?	<b>N/A</b>
N/A	Landing Slope (%)	<b>N/A</b>	N/A	DWS Length (in)	<b>N/A</b>
N/A	Landing X Slope (%)	<b>N/A</b>	N/A	DWS Full Width?	<b>N/A</b>
N/A	Landing Curb? (Y/N)	<b>N/A</b>	N/A	DWS Offset (in)	<b>N/A</b>
N/A	Shared Landing?	<b>N/A</b>			
N/A	Gutter Ponding?	<b>N/A</b>	N/A	Gutter Slope (%)	<b>N/A</b>
N/A	Gutter Lip Ht (in)	<b>N/A</b>	N/A	Gutter X Slope (%)	<b>N/A</b>
N/A	Painted X Walk1?	<b>No</b>	N/A	Painted X Walk2?	<b>N/A</b>

X Walk 1 Direction	<b>To N</b>		X Walk 2 Direction	<b>N/A</b>
N/A	X Walk 1 Width (in)	<b>N/A</b>	N/A	X Walk 2 Width (in)	<b>N/A</b>
	X Walk 1 Slope (%)	<b>4.6</b>		X Walk 2 Slope (%)	<b>N/A</b>
	X Walk 1 X Slope (%)	<b>1.1</b>		X Walk 2 X Slope (%)	<b>N/A</b>
N/A	Ramp inside XWalk1?	<b>N/A</b>	N/A	Ramp inside XWalk2?	<b>N/A</b>
	Road Slope (%)	<b>N/A</b>	N/A	Clear Space?	<b>N/A</b>
	Road X Slope (%)	<b>N/A</b>	N/A	Clear Space to XWalk (in)	<b>N/A</b>
N/A	Any Obstructions?	<b>N/A</b>	N/A	Storm Grate/Utility Hazard?	<b>N/A</b>
	Obstruction Type			Storm Grate/Utility Type	
		<b>N/A</b>			<b>N/A</b>
			Yes	Surface Condition? (G/P)	<b>Good</b>

Possible Solutions:

**Remove & Replace Entire Ramp.**

Total Cost: \$ **1850.00**
