Access Compliance Report

Public Rights-of-Way

(Curb Ramps)

Intersection ID: 48577	Main Street: THE_PLAZA	Cross Street: BRAMBLE_RIDGE_CT	Location: SE
ADA ID: 41EAD153785B	Ramp Type: Perp	Initial Pass/Fail: Fail	Overall Compliance: No
		Severity Score: 8.75

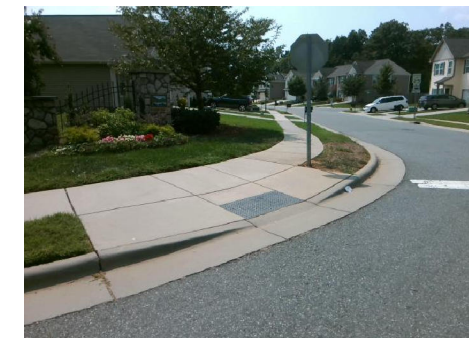
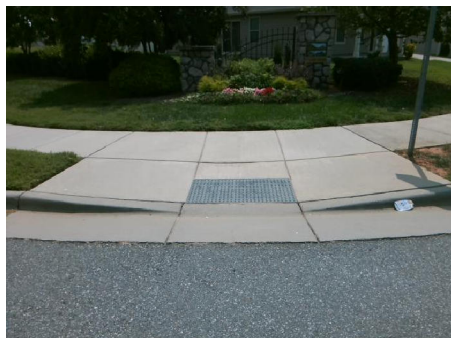
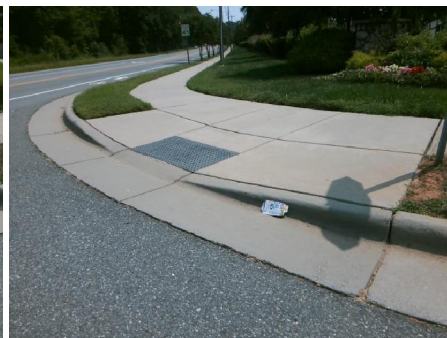
Not Found, R304.5.1

Compliance	Description	Data	Compliance	Description	Data
N/A	Ramp Length (in)	47.0	Yes	Ramp Slope (%)	5.2
No	Ramp Width (in)	47.5	Yes	Ramp XSlope (%)	1.3
N/A	Flare Type LT	N/A	N/A	Flare Type RT	N/A
N/A	Flare Slope LT (%)	N/A	N/A	Flare Slope RT (%)	N/A
N/A	Flare Traversable LT?	N/A	N/A	Flare Traversable RT?	N/A
N/A	Landing Length (in)	N/A	N/A	DWS Provided?	N/A
N/A	Landing Width (in)	N/A	N/A	DWS Contrast?	N/A
N/A	Landing Slope (%)	N/A	N/A	DWS Length (in)	N/A
N/A	Landing X Slope (%)	N/A	N/A	DWS Full Width?	N/A
N/A	Landing Curb? (Y/N)	N/A	N/A	DWS Offset (in)	N/A
N/A	Shared Landing?	N/A			
N/A	Gutter Ponding?	N/A	N/A	Gutter Slope (%)	N/A
N/A	Gutter Lip Ht (in)	N/A	N/A	Gutter X Slope (%)	N/A
N/A	Painted X Walk1?	No	N/A	Painted X Walk2?	N/A
	X Walk 1 Direction	To W		X Walk 2 Direction	N/A
N/A	X Walk 1 Width (in)	N/A	N/A	X Walk 2 Width (in)	N/A
	X Walk 1 Slope (%)	0.0		X Walk 2 Slope (%)	N/A
	X Walk 1 X Slope (%)	0.5		X Walk 2 X Slope (%)	N/A

Remove & Replace Entire Ramp.
