Access Compliance Report

Public Rights-of-Way

(Curb Ramps)

Intersection ID: 10032241	Main Street: MOSS_RD	Cross Street: N/A	Location: SW
ADA ID: 41F229B6F47D	Ramp Type: Directional1	Initial Pass/Fail: Fail	Overall Compliance: No
Severity Score: 33.75			
Codes/Mitigation Info/Possible Solution		Field Measurements/Component Compliance

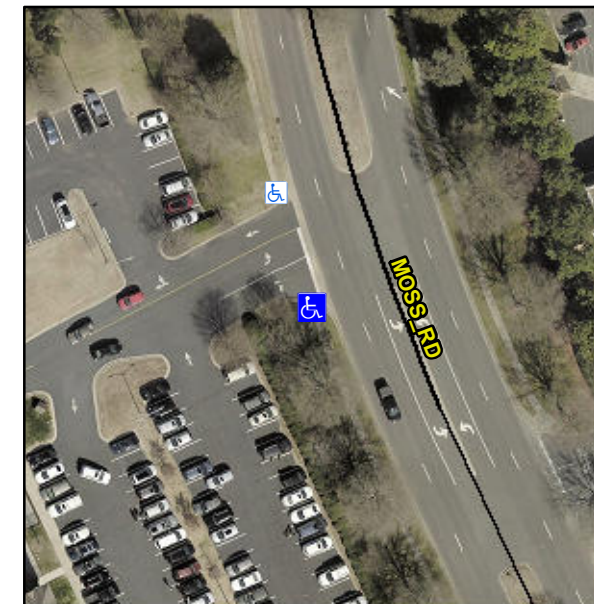
R304.5.1, R304.5.3

Compliance	Description	Data	Compliance	Description	Data
N/A	Ramp Length (in)	41.0	N/A	Grade Break?	N/A
No	Ramp Width (in)	47.0	N/A	Grade Break Slope (%)	0.0
Yes	Ramp Slope (%)	5.8	N/A	Grade Break XSlope (%)	0.0
No	Ramp XSlope (%)	10.3			
N/A	Flare Type LT	N/A	N/A	Flare Type RT	N/A
N/A	Flare Slope LT (%)	N/A	N/A	Flare Slope RT (%)	0.0
N/A	Flare Traversable LT?	N/A	N/A	Flare Traversable RT?	N/A
N/A	Landing Length (in)	0.0	N/A	DWS Provided?	N/A
N/A	Landing Width (in)	0.0	N/A	DWS Contrast?	N/A
N/A	Landing Slope (%)	0.0	N/A	DWS Length (in)	N/A
N/A	Landing X Slope (%)	0.0	N/A	DWS Full Width?	N/A
N/A	Landing Curb? (Y/N)	N/A	N/A	DWS Offset LT (in)	N/A
N/A	Shared Landing?	N/A	N/A	DWS Offset RT (in)	N/A
N/A	Gutter Ponding?	0.0	N/A	Gutter Slope (%)	N/A
N/A	Gutter Lip Ht (in)	0.0	N/A	Gutter X Slope (%)	N/A
N/A	Painted X Walk1?	No		Road Slope (%)	1.2
	X Walk 1 Direction	To NW		Road X Slope (%)	3.3
	X Walk 1 Width (in)	N/A		Clear Space?	N/A

X Walk 1 Slope (%)	1.2	N/A	Clear Space to XWalk (in)	N/A
	X Walk 1 X Slope (%)	3.3	N/A	Storm Grate/Utility Hazard?	N/A
N/A	Ramp inside XWalk1?	N/A		Storm Grate/Utility Type	
N/A	Any Obstructions?	N/A			N/A
	Obstruction Type		Yes	Surface Condition? (G/P)	Good
			N/A	Curb Slope (%)	1.8

Possible Solutions:

Remove & Replace Entire Ramp.

Total Cost: \$ 1600.00
