Access Compliance Report

Public Rights-of-Way

(Curb Ramps)

Intersection ID: 51011	Main Street: TREMONT_PLACE_RD	Cross Street: BENDING_BRANCH_RD	Location:	N
ADA ID: 42026600B573	Ramp Type: Perp	Initial Pass/Fail: Fail	Overall Compliance: No	Severity Score: 21.25
Codes/Mitigation Info/Possible Solution		Field Measurements/Component Compliance

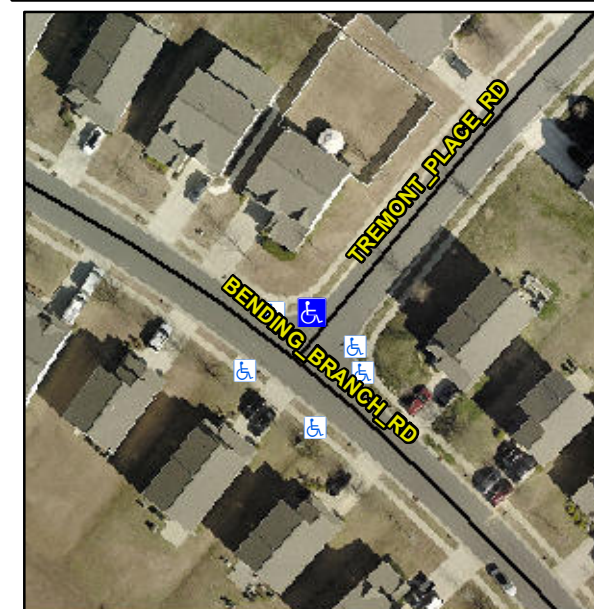
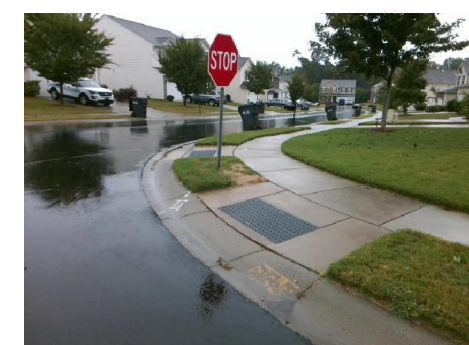
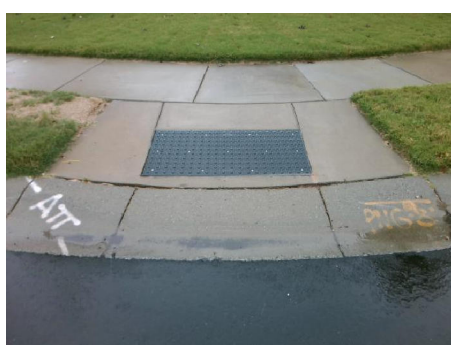
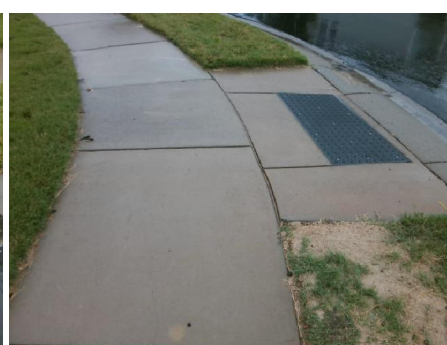
Not Found, R304.5.1, R304.2.2

Compliance	Description	Data	Compliance	Description	Data
N/A	Ramp Length (in)	48.5	No	Ramp Slope (%)	10.7
No	Ramp Width (in)	47.0	Yes	Ramp XSlope (%)	0.0
N/A	Flare Type LT	N/A	N/A	Flare Type RT	N/A
N/A	Flare Slope LT (%)	N/A	N/A	Flare Slope RT (%)	N/A
N/A	Flare Traversable LT?	N/A	N/A	Flare Traversable RT?	N/A
N/A	Landing Length (in)	N/A	N/A	DWS Provided?	N/A
N/A	Landing Width (in)	N/A	N/A	DWS Contrast?	N/A
N/A	Landing Slope (%)	N/A	N/A	DWS Length (in)	N/A
N/A	Landing X Slope (%)	N/A	N/A	DWS Full Width?	N/A
N/A	Landing Curb? (Y/N)	N/A	N/A	DWS Offset (in)	N/A
N/A	Shared Landing?	N/A			
N/A	Gutter Ponding?	N/A	N/A	Gutter Slope (%)	N/A
N/A	Gutter Lip Ht (in)	N/A	N/A	Gutter X Slope (%)	N/A
N/A	Painted X Walk1?	No	N/A	Painted X Walk2?	N/A
	X Walk 1 Direction	To SW		X Walk 2 Direction	N/A
N/A	X Walk 1 Width (in)	N/A	N/A	X Walk 2 Width (in)	N/A
	X Walk 1 Slope (%)	3.5		X Walk 2 Slope (%)	N/A
	X Walk 1 X Slope (%)	2.6		X Walk 2 X Slope (%)	N/A

N/A	Ramp inside XWalk1?	N/A	N/A	Ramp inside XWalk2?	N/A
	Road Slope (%)	N/A	N/A	Clear Space?	N/A
	Road X Slope (%)	N/A	N/A	Clear Space to XWalk (in)	N/A
N/A	Any Obstructions?	N/A	N/A	Storm Grate/Utility Hazard?	N/A
	Obstruction Type			Storm Grate/Utility Type	
		N/A			N/A
			Yes	Surface Condition? (G/P)	Good

Possible Solutions:

Remove & Replace Entire Ramp.
