Access Compliance Report

Public Rights-of-Way

(Curb Ramps)

Intersection ID: 10038266	Main Street: SMITHFIELD_CHURCH_RD	Cross Street: N/A	Location: E
ADA ID: 42028B48482F	Ramp Type: Perp	Initial Pass/Fail: Fail	Overall Compliance: No
		Severity Score: 8.75

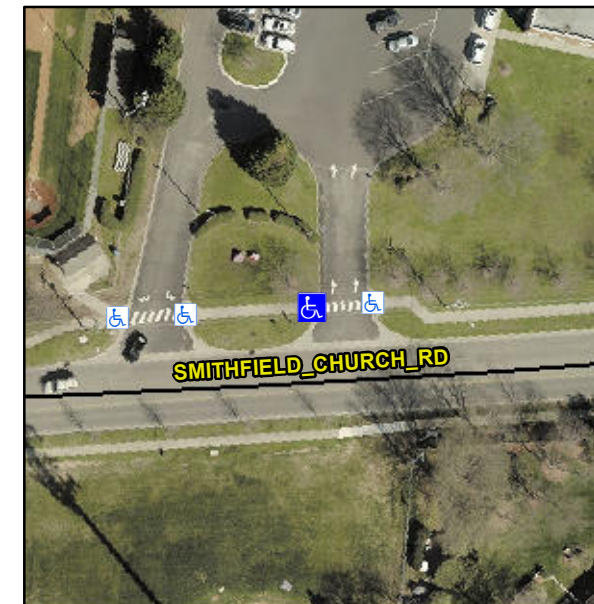
Not Found, R304.5.1

Compliance	Description	Data	Compliance	Description	Data
N/A	Ramp Length (in)	93.0	Yes	Ramp Slope (%)	6.1
No	Ramp Width (in)	47.0	Yes	Ramp XSlope (%)	1.1
N/A	Flare Type LT	N/A	N/A	Flare Type RT	N/A
N/A	Flare Slope LT (%)	N/A	N/A	Flare Slope RT (%)	N/A
N/A	Flare Traversable LT?	N/A	N/A	Flare Traversable RT?	N/A
N/A	Landing Length (in)	N/A	N/A	DWS Provided?	N/A
N/A	Landing Width (in)	N/A	N/A	DWS Contrast?	N/A
N/A	Landing Slope (%)	N/A	N/A	DWS Length (in)	N/A
N/A	Landing X Slope (%)	N/A	N/A	DWS Full Width?	N/A
N/A	Landing Curb? (Y/N)	N/A	N/A	DWS Offset (in)	N/A
N/A	Shared Landing?	N/A			
N/A	Gutter Ponding?	N/A	N/A	Gutter Slope (%)	N/A
N/A	Gutter Lip Ht (in)	N/A	N/A	Gutter X Slope (%)	N/A
N/A	Painted X Walk1?	Yes	N/A	Painted X Walk2?	N/A
	X Walk 1 Direction	To E		X Walk 2 Direction	N/A
N/A	X Walk 1 Width (in)	60.0	N/A	X Walk 2 Width (in)	N/A
	X Walk 1 Slope (%)	0.0		X Walk 2 Slope (%)	N/A
	X Walk 1 X Slope (%)	1.5		X Walk 2 X Slope (%)	N/A

N/A	Ramp inside XWalk1?	Yes	N/A	Ramp inside XWalk2?	N/A
	Road Slope (%)	N/A	N/A	Clear Space?	N/A
	Road X Slope (%)	N/A	N/A	Clear Space to XWalk (in)	N/A
N/A	Any Obstructions?	N/A	N/A	Storm Grate/Utility Hazard?	N/A
	Obstruction Type			Storm Grate/Utility Type	
		N/A			N/A
			Yes	Surface Condition? (G/P)	Good

Remove & Replace Entire Ramp.
