# Access Compliance Report

## Public Rights-of-Way

### (Curb Ramps)

Intersection ID: 7457	Main Street: CANTERWOOD_DR	Cross Street: ELGYWOOD_LN	Location: NW
ADA ID: 420A1FFF056F	Ramp Type: BlendTrans1	Initial Pass/Fail: Fail	Overall Compliance: No
Severity Score: 8.75			
Codes/Mitigation Info/Possible Solution		Field Measurements/Component Compliance

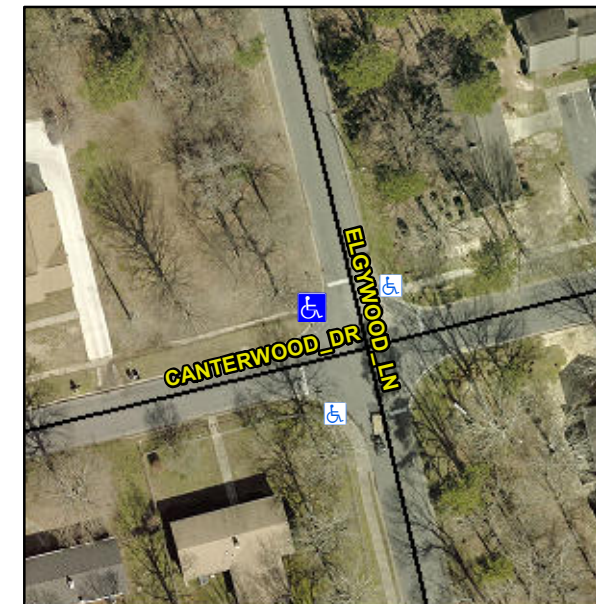
**Not Found, R304.5.1**

Compliance	Description	Data	Compliance	Description	Data
N/A	Ramp Length (in)	81.5	Yes	BlendTrans Slope (%)	2.5
No	Ramp Width (in)	44.0	Yes	BlendTrans XSlope (%)	1.6
N/A	Flare Type LT	N/A	N/A	Flare Type RT	N/A
N/A	Flare Slope LT (%)	N/A	N/A	Flare Slope RT (%)	N/A
N/A	Flare Traversable LT?	N/A	N/A	Flare Traversable RT?	N/A
N/A	Landing Length (in)	N/A	N/A	DWS Provided?	N/A
N/A	Landing Width (in)	N/A	N/A	DWS Contrast?	N/A
N/A	Landing Slope (%)	N/A	N/A	DWS Length (in)	N/A
N/A	Landing X Slope (%)	N/A	N/A	DWS Full Width?	N/A
N/A	Landing Curb? (Y/N)	N/A	N/A	DWS Offset (in)	N/A
N/A	Shared Landing?	N/A			
N/A	Gutter Ponding?	N/A	N/A	Gutter Slope (%)	N/A
N/A	Gutter Lip Ht (in)	N/A	N/A	Gutter X Slope (%)	N/A
N/A	Painted X Walk1?	No	N/A	Painted X Walk2?	No
	X Walk 1 Direction	To SW		X Walk 2 Direction	To E
	X Walk 1 Width (in)	N/A		X Walk 2 Width (in)	N/A
	X Walk 1 Slope (%)	2.5		X Walk 2 Slope (%)	0.9
	X Walk 1 X Slope (%)	0.2		X Walk 2 X Slope (%)	0.2

N/A	Ramp inside XWalk1?	N/A	N/A	Ramp inside XWalk2?	N/A
	Road Slope (%)	1.6		Clear Space?	N/A
	Road X Slope (%)	2.1	N/A	Clear Space to XWalk (in)	N/A
N/A	Any Obstructions?	N/A	N/A	Storm Grate/Utility Hazard?	N/A
	Obstruction Type			Storm Grate/Utility Type	
		N/A			N/A
			Yes	Surface Condition? (G/P)	Good
			No	Curb Slope (%)	11.9

**Remove & Replace Curb Ramp With Two New Directional Ramps or Equivalent.**

Total Cost: \$ 3200.00
