# Access Compliance Report

## Public Rights-of-Way

### (Curb Ramps)

| Intersection ID: 16594 | Main Street: BOSTON_AV | Cross Street: SPRINGFIELD_DR | Location: NE |

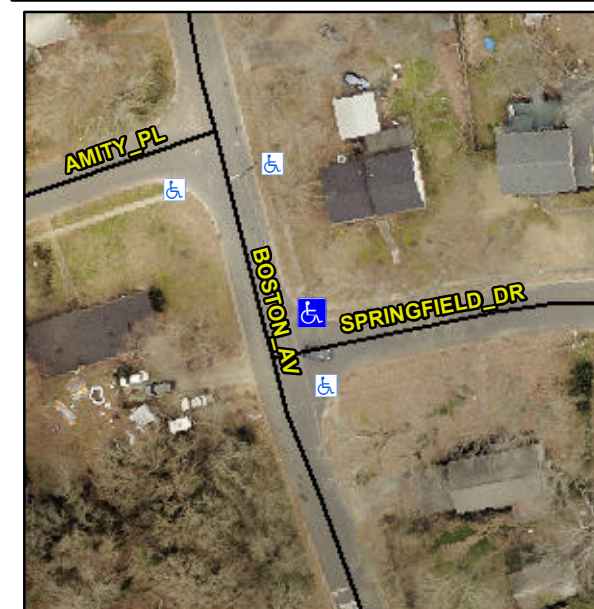
| ADA ID: 421635C116D9 | Ramp Type: PerpDiag | Initial Pass/Fail: Fail | Overall Compliance: No |
| Severity Score: 8.75 | | | |

**R304.5.1**

| Compliance | Description | Data | Compliance | Description | Data |
|---|---|---|---|---|---|
| No | Ramp Width (in) | 46.0 | Yes | Ramp XSlope (%) | 0.9 |

**Remove & Replace Curb Ramp With Two New Directional Ramps or Equivalent.**

Total Cost: \$ 3200.00
