Access Compliance Report

Public Rights-of-Way

(Curb Ramps)

Intersection ID: 48432	Main Street: WHITHORN_WY	Cross Street: SEAMILL_RD	Location: NW
ADA ID: 421B19D2D848	Ramp Type: Perp	Initial Pass/Fail: Pass	Overall Compliance: No
			Severity Score: 0.25

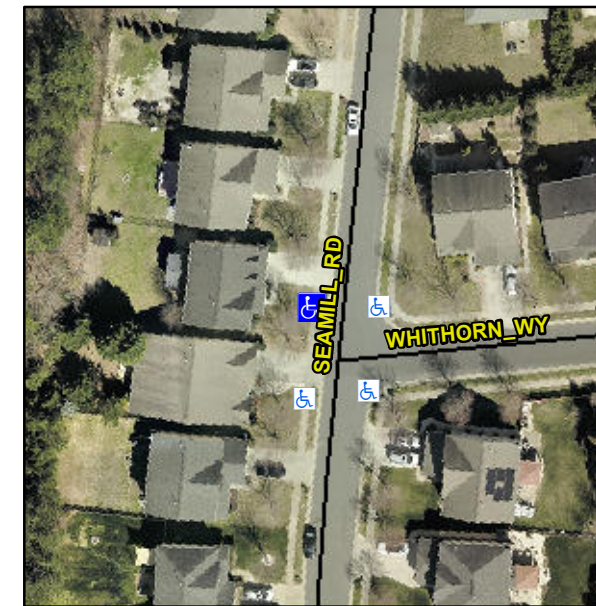
Compliance	Description	Data	Compliance	Description	Data
N/A	Ramp Length (in)	47.0	Yes	Ramp Slope (%)	7.6
Yes	Ramp Width (in)	48.0	Yes	Ramp XSlope (%)	3.9
N/A	Flare Type LT	Sloped	N/A	Flare Type RT	N/A
N/A	Flare Slope LT (%)	0.9	N/A	Flare Slope RT (%)	8.0
N/A	Flare Traversable LT?	No	N/A	Flare Traversable RT?	No
Yes	Landing Length (in)	48.0	Yes	DWS Provided?	Yes
Yes	Landing Width (in)	48.0	Yes	DWS Contrast?	Yes
No	Landing Slope (%)	3.0	Yes	DWS Length (in)	24.0
No	Landing X Slope (%)	4.7	Yes	DWS Full Width?	Yes
N/A	Landing Curb? (Y/N)	No	Yes	DWS Offset (in)	0.5
N/A	Shared Landing?	No			
Yes	Gutter Ponding?	No	Yes	Gutter Slope (%)	2.8
Yes	Gutter Lip Ht (in)	0.0	Yes	Gutter X Slope (%)	3.2
N/A	Painted X Walk1?	No	N/A	Painted X Walk2?	N/A
	X Walk 1 Direction	To E		X Walk 2 Direction	N/A
N/A	X Walk 1 Width (in)	N/A	N/A	X Walk 2 Width (in)	N/A
	X Walk 1 Slope (%)	3.8		X Walk 2 Slope (%)	N/A
	X Walk 1 X Slope (%)	4.0		X Walk 2 X Slope (%)	N/A

N/A	Ramp inside XWalk1?	N/A	N/A	Ramp inside XWalk2?	N/A
	Road Slope (%)	N/A	N/A	Clear Space?	Yes
	Road X Slope (%)	N/A	N/A	Clear Space to XWalk (in)	N/A
Yes	Any Obstructions?	No	Yes	Storm Grate/Utility Hazard?	No
	Obstruction Type			Storm Grate/Utility Type	
			N/A		N/A
			Yes	Surface Condition? (G/P)	Good

Remove & Replace Landing.
