# Access Compliance Report

## Public Rights-of-Way

### (Curb Ramps)

Intersection ID: 7516	Main Street: BEATTIES_FORD_RD	Cross Street: BISHOP_MADISON_LN	Location: SE
ADA ID: 42243F7BD2AB	Ramp Type: Perp	Initial Pass/Fail: Fail	Overall Compliance: No
Severity Score: 22.5			
Codes/Mitigation Info/Possible Solution		Field Measurements/Component Compliance

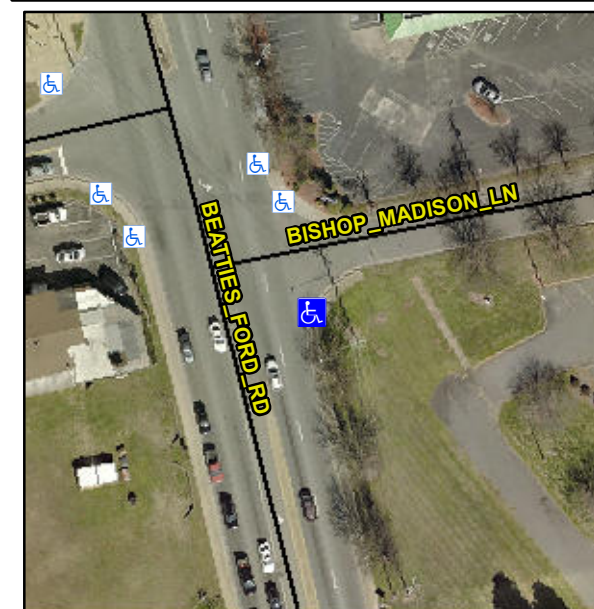
**Not Found, R304.5.1, R304.2.2, R304.5.3**

Compliance	Description	Data	Compliance	Description	Data
N/A	Ramp Length (in)	60.5	No	Ramp Slope (%)	9.1
No	Ramp Width (in)	47.0	No	Ramp XSlope (%)	2.3
N/A	Flare Type LT	N/A	N/A	Flare Type RT	N/A
N/A	Flare Slope LT (%)	N/A	N/A	Flare Slope RT (%)	N/A
N/A	Flare Traversable LT?	N/A	N/A	Flare Traversable RT?	N/A
N/A	Landing Length (in)	N/A	N/A	DWS Provided?	N/A
N/A	Landing Width (in)	N/A	N/A	DWS Contrast?	N/A
N/A	Landing Slope (%)	N/A	N/A	DWS Length (in)	N/A
N/A	Landing X Slope (%)	N/A	N/A	DWS Full Width?	N/A
N/A	Landing Curb? (Y/N)	N/A	N/A	DWS Offset (in)	N/A
N/A	Shared Landing?	N/A			
N/A	Gutter Ponding?	N/A	N/A	Gutter Slope (%)	N/A
N/A	Gutter Lip Ht (in)	N/A	N/A	Gutter X Slope (%)	N/A
N/A	Painted X Walk1?	No	N/A	Painted X Walk2?	N/A
	X Walk 1 Direction	To N		X Walk 2 Direction	N/A
N/A	X Walk 1 Width (in)	N/A	N/A	X Walk 2 Width (in)	N/A
	X Walk 1 Slope (%)	0.8		X Walk 2 Slope (%)	N/A
	X Walk 1 X Slope (%)	4.9		X Walk 2 X Slope (%)	N/A

N/A	Ramp inside XWalk1?	N/A	N/A	Ramp inside XWalk2?	N/A
	Road Slope (%)	N/A	N/A	Clear Space?	N/A
	Road X Slope (%)	N/A	N/A	Clear Space to XWalk (in)	N/A
N/A	Any Obstructions?	N/A	N/A	Storm Grate/Utility Hazard?	N/A
	Obstruction Type			Storm Grate/Utility Type	
		N/A			N/A
			Yes	Surface Condition? (G/P)	Good

**Remove & Replace Entire Ramp.**
