Access Compliance Report

Public Rights-of-Way

(Curb Ramps)

Intersection ID: 17621	Main Street: CROYDON_RD	Cross Street: RIDGEWOOD_AV	Location: S
ADA ID: 4235FF8E06A0	Ramp Type: Perp	Initial Pass/Fail: Fail	Overall Compliance: No
		Severity Score: 1.25

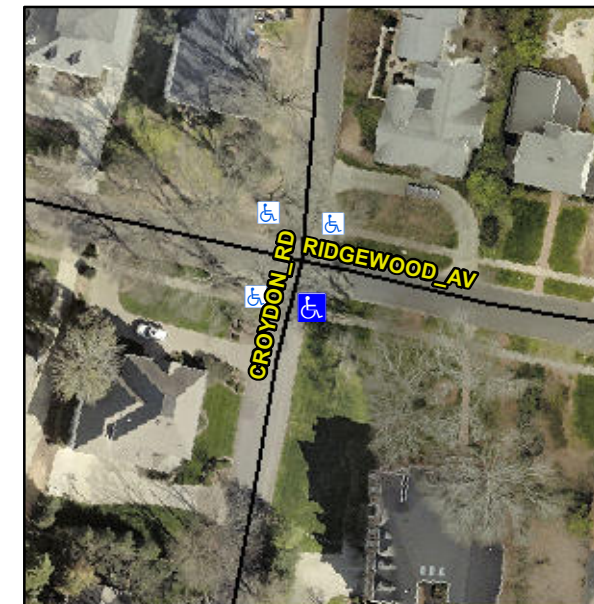
Compliance	Description	Data	Compliance	Description	Data
N/A	Ramp Length (in)	150.0	Yes	Ramp Slope (%)	6.5
Yes	Ramp Width (in)	53.0	No	Ramp XSlope (%)	3.5
N/A	Flare Type LT	N/A	N/A	Flare Type RT	N/A
N/A	Flare Slope LT (%)	N/A	N/A	Flare Slope RT (%)	N/A
N/A	Flare Traversable LT?	N/A	N/A	Flare Traversable RT?	N/A
N/A	Landing Length (in)	N/A	N/A	DWS Provided?	N/A
N/A	Landing Width (in)	N/A	N/A	DWS Contrast?	N/A
N/A	Landing Slope (%)	N/A	N/A	DWS Length (in)	N/A
N/A	Landing X Slope (%)	N/A	N/A	DWS Full Width?	N/A
N/A	Landing Curb? (Y/N)	N/A	N/A	DWS Offset (in)	N/A
N/A	Shared Landing?	N/A			
N/A	Gutter Ponding?	N/A	N/A	Gutter Slope (%)	N/A
N/A	Gutter Lip Ht (in)	N/A	N/A	Gutter X Slope (%)	N/A
N/A	Painted X Walk1?	No	N/A	Painted X Walk2?	N/A
	X Walk 1 Direction	To NW		X Walk 2 Direction	N/A
N/A	X Walk 1 Width (in)	N/A	N/A	X Walk 2 Width (in)	N/A
	X Walk 1 Slope (%)	1.5		X Walk 2 Slope (%)	N/A
	X Walk 1 X Slope (%)	0.9		X Walk 2 X Slope (%)	N/A

N/A	Ramp inside XWalk1?	N/A	N/A	Ramp inside XWalk2?	N/A
	Road Slope (%)	N/A	N/A	Clear Space?	N/A
	Road X Slope (%)	N/A	N/A	Clear Space to XWalk (in)	N/A
N/A	Any Obstructions?	N/A	N/A	Storm Grate/Utility Hazard?	N/A
	Obstruction Type			Storm Grate/Utility Type	
		N/A			N/A
		Yes		Surface Condition? (G/P)	Good

Possible Solutions:

Remove & Replace Entire Ramp.

R304.5.3

\$ 1850.00
