Access Compliance Report

Public Rights-of-Way

(Curb Ramps)

Intersection ID: 10035869	Main Street: REXFORD_RD	Cross Street: N/A	Location: SE
ADA ID: 423B44159467	Ramp Type: Perp	Initial Pass/Fail: Fail	Overall Compliance: No
Codes/Mitigation Info/Possible Solution		Field Measurements/Component Compliance	
Severity Score: 13.75

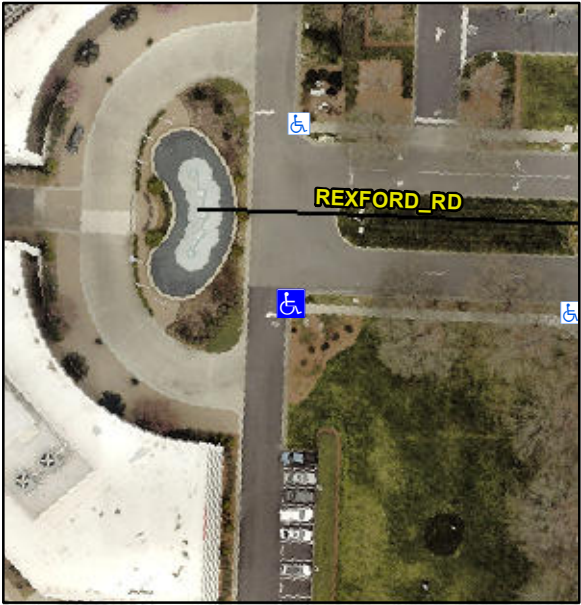
Possible Solutions:	Compliance	Description	Data	Compliance	Description	Data
	Remove & Replace Entire Ramp.	N/A	Ramp Length (in)	62.0	No	Ramp Slope (%)	10.3
		Yes	Ramp Width (in)	48.0	No	Ramp XSlope (%)	2.6
		N/A	Flare Type LT	N/A	N/A	Flare Type RT	N/A
		N/A	Flare Slope LT (%)	N/A	N/A	Flare Slope RT (%)	N/A
		N/A	Flare Traversable LT?	N/A	N/A	Flare Traversable RT?	N/A
		N/A	Landing Length (in)	N/A	N/A	DWS Provided?	N/A
		N/A	Landing Width (in)	N/A	N/A	DWS Contrast?	N/A
		N/A	Landing Slope (%)	N/A	N/A	DWS Length (in)	N/A
		N/A	Landing X Slope (%)	N/A	N/A	DWS Full Width?	N/A
<p>Surveyor Notes:</p> <p>N/A</p> <p>PROW/ADA:</p> <p>R304.2.2, R304.5.3</p>		N/A	Landing Curb? (Y/N)	N/A	N/A	DWS Offset (in)	N/A
		N/A	Shared Landing?	N/A			
		N/A	Gutter Ponding?	N/A	N/A	Gutter Slope (%)	N/A
		N/A	Gutter Lip Ht (in)	N/A	N/A	Gutter X Slope (%)	N/A
		N/A	Painted X Walk1?	No	N/A	Painted X Walk2?	N/A
			X Walk 1 Direction	To W		X Walk 2 Direction	N/A

N/A	X Walk 1 Width (in)	N/A	N/A	X Walk 2 Width (in)	N/A
			X Walk 1 Slope (%)	5.1		X Walk 2 Slope (%)	N/A
			X Walk 1 X Slope (%)	2.5		X Walk 2 X Slope (%)	N/A
		N/A	Ramp inside XWalk1?	N/A	N/A	Ramp inside XWalk2?	N/A
<p>Street 1 Name</p> <p>Stop Condition-Street 2</p> <p>Street 2 Name</p> <p>Stop Condition-Street 1</p>			Road Slope (%)	N/A	N/A	Clear Space?	N/A
			Road X Slope (%)	N/A	N/A	Clear Space to XWalk (in)	N/A
		N/A	Any Obstructions?	N/A	N/A	Storm Grate/Utility Hazard?	N/A
			Obstruction Type			Storm Grate/Utility Type	
					N/A		N/A
					Yes	Surface Condition? (G/P)	Good
Total Cost:		\$	1850.00
