Access Compliance Report

Public Rights-of-Way

(Curb Ramps)

Intersection ID: 12629	Main Street: E_6TH_ST	Cross Street: N_DAVIDSON_ST	Location: W
ADA ID: 424ABC258A90	Ramp Type: PerpDiag	Initial Pass/Fail: Fail	Overall Compliance: No
Severity Score: 22.5			
Codes/Mitigation Info/Possible Solution		Field Measurements/Component Compliance

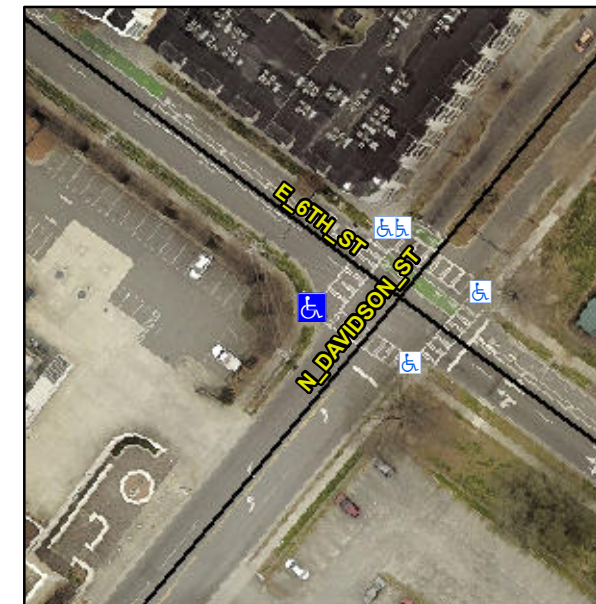
Not Found, R304.5.1, R304.2.2

Compliance	Description	Data	Compliance	Description	Data
N/A	Ramp Length (in)	78.0	No	Ramp Slope (%)	8.5
No	Ramp Width (in)	36.0	Yes	Ramp XSlope (%)	3.3
N/A	Flare Type LT	N/A	N/A	Flare Type RT	N/A
N/A	Flare Slope LT (%)	N/A	N/A	Flare Slope RT (%)	N/A
N/A	Flare Traversable LT?	N/A	N/A	Flare Traversable RT?	N/A
N/A	Landing Length (in)	N/A	N/A	DWS Provided?	N/A
N/A	Landing Width (in)	N/A	N/A	DWS Contrast?	N/A
N/A	Landing Slope (%)	N/A	N/A	DWS Length (in)	N/A
N/A	Landing X Slope (%)	N/A	N/A	DWS Full Width?	N/A
N/A	Landing Curb? (Y/N)	N/A	N/A	DWS Offset (in)	N/A
N/A	Shared Landing?	N/A			
N/A	Gutter Ponding?	Yes	N/A	Gutter Slope (%)	N/A
N/A	Gutter Lip Ht (in)	N/A	N/A	Gutter X Slope (%)	N/A
N/A	Painted X Walk1?	Yes	N/A	Painted X Walk2?	Yes
	X Walk 1 Direction	To SE		X Walk 2 Direction	To NE
N/A	X Walk 1 Width (in)	109.0	N/A	X Walk 2 Width (in)	107.5
	X Walk 1 Slope (%)	1.3		X Walk 2 Slope (%)	2.5
	X Walk 1 X Slope (%)	2.6		X Walk 2 X Slope (%)	1.0

N/A	Ramp inside XWalk1?	Yes	N/A	Ramp inside XWalk2?	Yes
	Road Slope (%)	3.5	N/A	Clear Space?	N/A
	Road X Slope (%)	1.1	N/A	Clear Space to XWalk (in)	N/A
N/A	Any Obstructions?	N/A	N/A	Storm Grate/Utility Hazard?	N/A
	Obstruction Type			Storm Grate/Utility Type	
		N/A			N/A
		Yes		Surface Condition? (G/P)	Good

Remove & Replace Curb Ramp With Two New Directional Ramps or Equivalent.

Total Cost: \$ 3200.00
