# Access Compliance Report

## Public Rights-of-Way

### (Curb Ramps)

Intersection ID: 2881	Main Street: SWALLOW_TAIL_LN	Cross Street: RED_CLOVER_LN	Location: W
ADA ID: 424E310DF7B9	Ramp Type: Perp	Initial Pass/Fail: Pass	Overall Compliance: No
Severity Score: 0			
Codes/Mitigation Info/Possible Solution		Field Measurements/Component Compliance

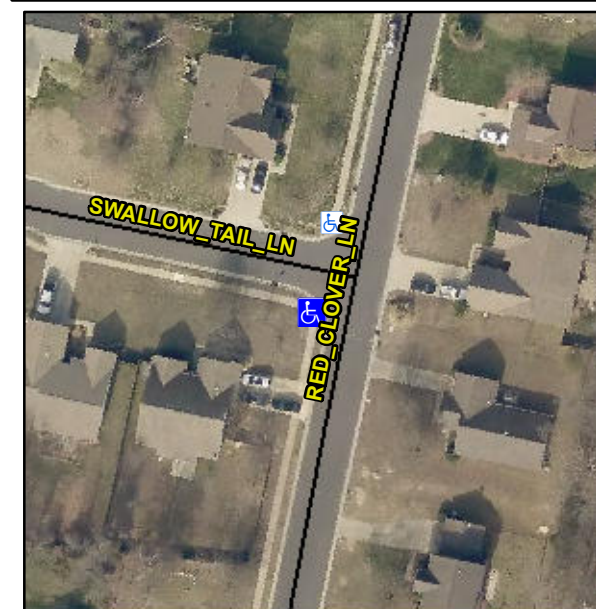
Compliance	Description	Data	Compliance	Description	Data
N/A	Ramp Length (in)	52.0	Yes	Ramp Slope (%)	7.3
Yes	Ramp Width (in)	50.0	Yes	Ramp XSlope (%)	1.1
N/A	Flare Type LT	Sloped	N/A	Flare Type RT	N/A
N/A	Flare Slope LT (%)	1.6	Yes	Flare Slope RT (%)	3.8
N/A	Flare Traversable LT?	Yes	N/A	Flare Traversable RT?	Yes
No	Landing Length (in)	47.0	Yes	DWS Provided?	Yes
Yes	Landing Width (in)	50.0	Yes	DWS Contrast?	Yes
No	Landing Slope (%)	2.9	Yes	DWS Length (in)	24.0
No	Landing X Slope (%)	3.2	Yes	DWS Full Width?	Yes
N/A	Landing Curb? (Y/N)	No	No	DWS Offset (in)	3.0
N/A	Shared Landing?	No			
Yes	Gutter Ponding?	No	Yes	Gutter Slope (%)	1.7
Yes	Gutter Lip Ht (in)	0.0	Yes	Gutter X Slope (%)	1.8
N/A	Painted X Walk1?	No	N/A	Painted X Walk2?	N/A
	X Walk 1 Direction	To NE		X Walk 2 Direction	N/A
N/A	X Walk 1 Width (in)	N/A	N/A	X Walk 2 Width (in)	N/A
	X Walk 1 Slope (%)	3.4		X Walk 2 Slope (%)	N/A
	X Walk 1 X Slope (%)	0.4		X Walk 2 X Slope (%)	N/A

N/A	Ramp inside XWalk1?	N/A	N/A	Ramp inside XWalk2?	N/A
	Road Slope (%)	N/A	N/A	Clear Space?	Yes
	Road X Slope (%)	N/A	N/A	Clear Space to XWalk (in)	N/A
Yes	Any Obstructions?	No	Yes	Storm Grate/Utility Hazard?	No
	Obstruction Type			Storm Grate/Utility Type	
		N/A			N/A
			Yes	Surface Condition? (G/P)	Good

Possible Solutions:

**Remove & Replace Entire Ramp.**
