# Access Compliance Report

## Public Rights-of-Way

### (Curb Ramps)

Intersection ID: 19049	Main Street: BRAEBURN_RD	Cross Street: ROCKY_FALLS_RD	Location: NE
ADA ID: 4251EEF7AEED	Ramp Type: BlendTrans2	Initial Pass/Fail: Fail	Overall Compliance: No
		Severity Score: 12.5

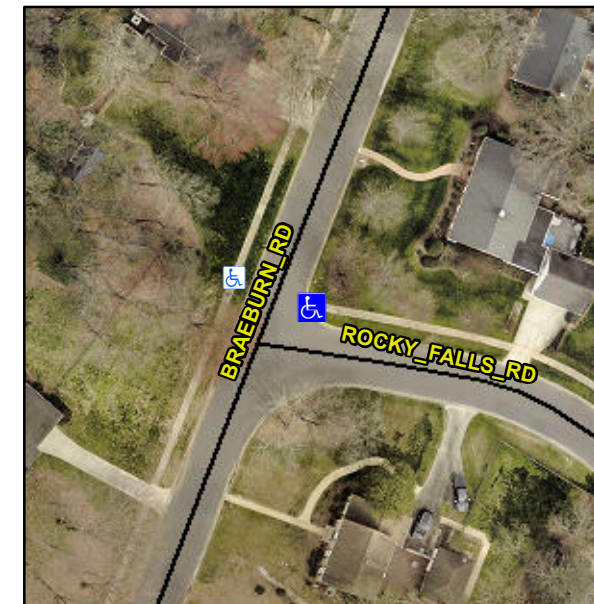
**Not Found, R304.5.3**

Compliance	Description	Data	Compliance	Description	Data
N/A	Ramp Length (in)	80.0	Yes	BlendTrans Slope (%)	1.2
Yes	Ramp Width (in)	48.0	No	BlendTrans XSlope (%)	5.2
N/A	Flare Type LT	N/A	N/A	Flare Type RT	N/A
N/A	Flare Slope LT (%)	N/A	N/A	Flare Slope RT (%)	N/A
N/A	Flare Traversable LT?	N/A	N/A	Flare Traversable RT?	N/A
N/A	Landing Length (in)	N/A	N/A	DWS Provided?	N/A
N/A	Landing Width (in)	N/A	N/A	DWS Contrast?	N/A
N/A	Landing Slope (%)	N/A	N/A	DWS Length (in)	N/A
N/A	Landing X Slope (%)	N/A	N/A	DWS Full Width?	N/A
N/A	Landing Curb? (Y/N)	N/A	N/A	DWS Offset (in)	N/A
N/A	Shared Landing?	N/A			
N/A	Gutter Ponding?	N/A	N/A	Gutter Slope (%)	N/A
N/A	Gutter Lip Ht (in)	N/A	N/A	Gutter X Slope (%)	N/A
N/A	Painted X Walk1?	No	N/A	Painted X Walk2?	No
	X Walk 1 Direction	To W		X Walk 2 Direction	To S
	X Walk 1 Width (in)	N/A		X Walk 2 Width (in)	N/A
	X Walk 1 Slope (%)	2.7		X Walk 2 Slope (%)	3.9
	X Walk 1 X Slope (%)	3.4		X Walk 2 X Slope (%)	3.3

N/A	Ramp inside XWalk1?	N/A	N/A	Ramp inside XWalk2?	N/A
	Road Slope (%)	7.6		Clear Space?	N/A
	Road X Slope (%)	1.8	N/A	Clear Space to XWalk (in)	N/A
N/A	Any Obstructions?	N/A	N/A	Storm Grate/Utility Hazard?	N/A
	Obstruction Type			Storm Grate/Utility Type	
		N/A			N/A
			Yes	Surface Condition? (G/P)	Good
			No	Curb Slope (%)	9.6

**Remove & Replace Curb Ramp With Two New Directional Ramps or Equivalent.**

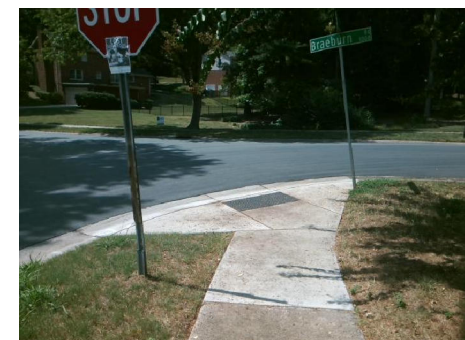
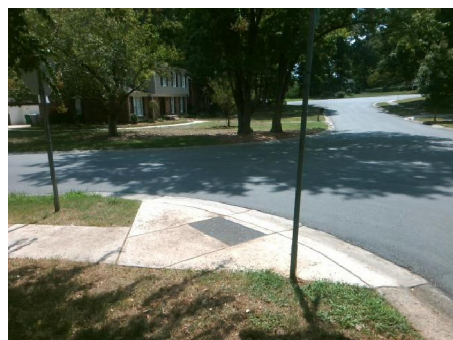
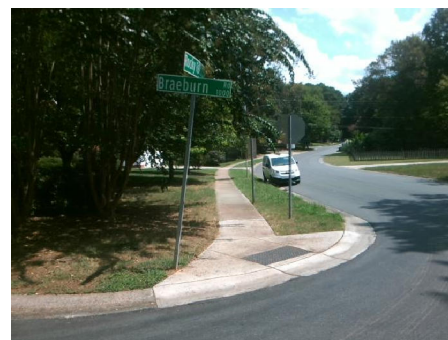
Street 1 Name BRAEBURN RD  
 Stop Condition-Street 1 None  
 Street 2 Name ROCKY FALLS RD  
 Stop Condition-Street 2 StopSign
