Access Compliance Report

Public Rights-of-Way

(Curb Ramps)

Intersection ID: 11337	Main Street: DELGANY_DR	Cross Street: TIPPERARY_PL	Location: SW
ADA ID: 425504DC27F2	Ramp Type: PerpDiag	Initial Pass/Fail: Fail	Overall Compliance: No
Codes/Mitigation Info/Possible Solution		Field Measurements/Component Compliance

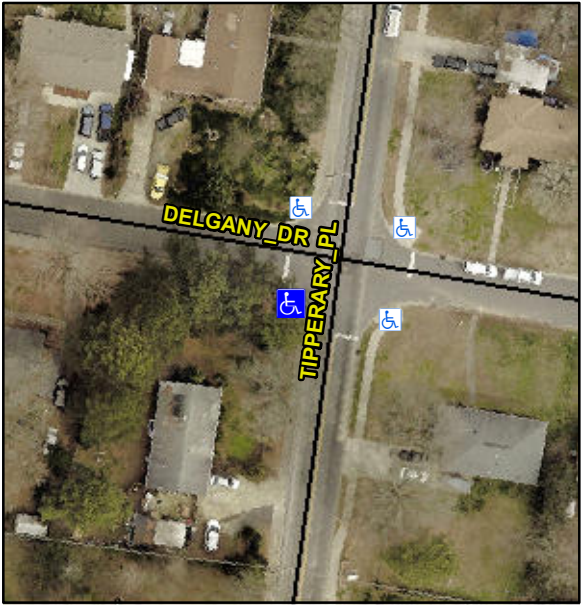
Compliance	Description	Data	Compliance	Description	Data
N/A	Ramp Length (in)	42.5	No	Ramp Slope (%)	11.4
Yes	Ramp Width (in)	60.0	Yes	Ramp XSlope (%)	0.5
N/A	Flare Type LT	N/A	N/A	Flare Type RT	N/A
N/A	Flare Slope LT (%)	N/A	N/A	Flare Slope RT (%)	N/A
N/A	Flare Traversable LT?	N/A	N/A	Flare Traversable RT?	N/A
N/A	Landing Length (in)	N/A	N/A	DWS Provided?	N/A
N/A	Landing Width (in)	N/A	N/A	DWS Contrast?	N/A
N/A	Landing Slope (%)	N/A	N/A	DWS Length (in)	N/A
N/A	Landing X Slope (%)	N/A	N/A	DWS Full Width?	N/A
N/A	Landing Curb? (Y/N)	N/A	N/A	DWS Offset (in)	N/A
N/A	Shared Landing?	N/A			
N/A	Gutter Ponding?	N/A	N/A	Gutter Slope (%)	N/A
N/A	Gutter Lip Ht (in)	N/A	N/A	Gutter X Slope (%)	N/A
N/A	Painted X Walk1?	No	N/A	Painted X Walk2?	No
	X Walk 1 Direction	To E		X Walk 2 Direction	To N
N/A	X Walk 1 Width (in)	N/A	N/A	X Walk 2 Width (in)	N/A
	X Walk 1 Slope (%)	5.0		X Walk 2 Slope (%)	3.5
	X Walk 1 X Slope (%)	1.0		X Walk 2 X Slope (%)	3.4

N/A	Ramp inside XWalk1?	N/A	N/A	Ramp inside XWalk2?	N/A
	Road Slope (%)	2.0	N/A	Clear Space?	N/A
	Road X Slope (%)	6.1	N/A	Clear Space to XWalk (in)	N/A
N/A	Any Obstructions?	N/A	N/A	Storm Grate/Utility Hazard?	N/A
	Obstruction Type			Storm Grate/Utility Type	
		N/A			N/A
			Yes	Surface Condition? (G/P)	Good

Possible Solutions:			
	Remove & Replace Curb Ramp With Two New Directional Ramps or Equivalent.			
	Surveyor Notes:			
	N/A			
	PROW/ADA:			
	Not Found, R304.2.2			
Street 1 Name	TIPPERARY PL			
Stop Condition-Street 2	StopSign			
Street 2 Name	DELGANY DR			
Stop Condition-Street 1	StopSign			
Total Cost:		\$	3200.00
