# Access Compliance Report

## Public Rights-of-Way

### (Curb Ramps)

| Intersection ID: 10527 | Main Street: PARKWAY_AV | Cross Street: TUCKASEEGEE_RD | Location: SE |

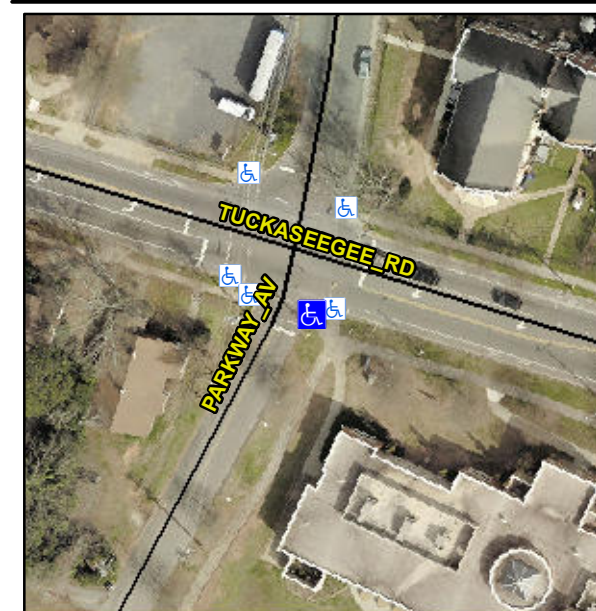
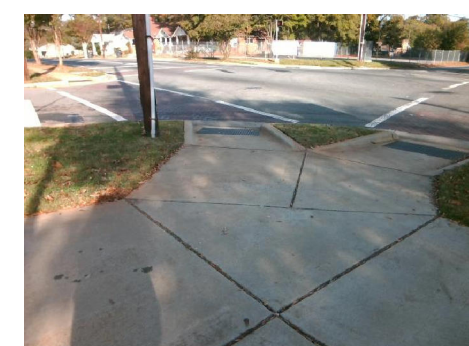
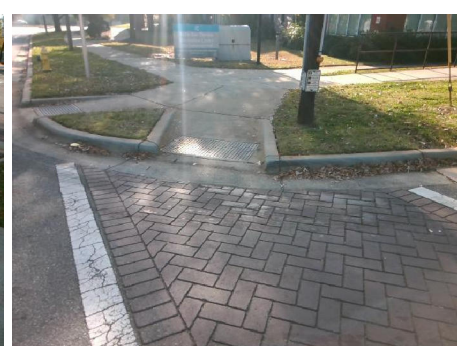
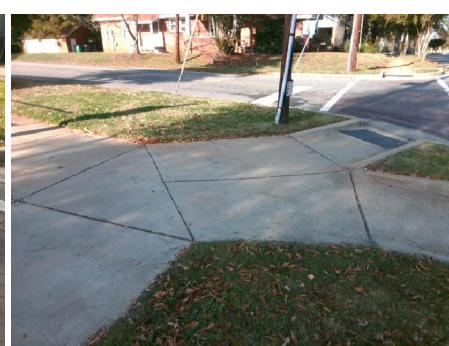
| ADA ID: 426231B6A2AA | Ramp Type: Perp | Initial Pass/Fail: Pass | Overall Compliance: No |
| Severity Score: 2.75 | | | |

**Not Found, R304.5.3, R304.2.2-Perp,  
R304.3.2-Para, R305.1.4**

| Compliance | Description | Data | Compliance | Description | Data |
|---|---|---|---|---|---|
| Yes | Ramp Width (in) | 55.0 | No | Ramp XSlope (%) | 3.4 |
| No | Landing Slope (%) | 2.6 | Yes | DWS Length (in) | 24.5 |
| No | Landing X Slope (%) | 2.4 | No | DWS Full Width? | No |
| Yes | Gutter Lip Ht (in) | 0.0 | No | Gutter X Slope (%) | 3.4 |

**Remove & Replace Entire Ramp.  
Remove & Replace Gutter.**
