Access Compliance Report

Public Rights-of-Way

(Curb Ramps)

Intersection ID: 11119	Main Street: WALNUT_AV	Cross Street: W_4TH_ST	Location: E
ADA ID: 4263C8B7C6F1	Ramp Type: Perp	Initial Pass/Fail: Fail	Overall Compliance: No
Severity Score: 8.75			
Codes/Mitigation Info/Possible Solution		Field Measurements/Component Compliance

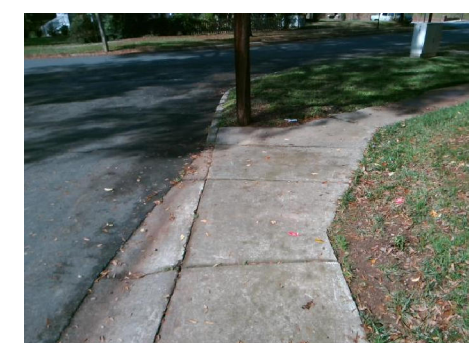
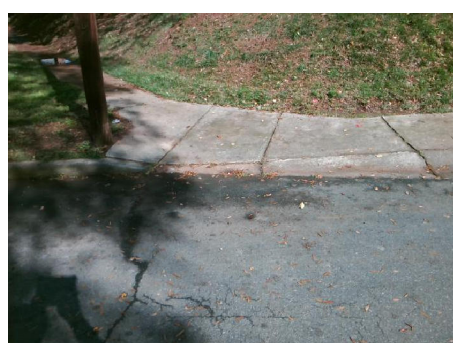
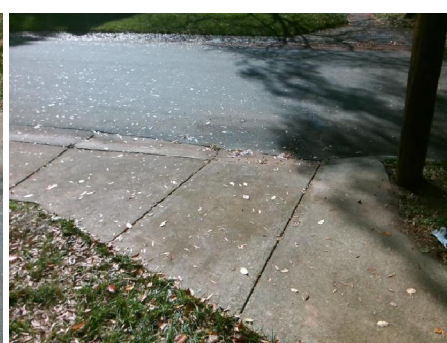
Not Found, R304.5.1

Compliance	Description	Data	Compliance	Description	Data
N/A	Ramp Length (in)	67.0	Yes	Ramp Slope (%)	7.8
No	Ramp Width (in)	47.0	Yes	Ramp XSlope (%)	0.2
N/A	Flare Type LT	N/A	N/A	Flare Type RT	N/A
N/A	Flare Slope LT (%)	N/A	N/A	Flare Slope RT (%)	N/A
N/A	Flare Traversable LT?	N/A	N/A	Flare Traversable RT?	N/A
N/A	Landing Length (in)	N/A	N/A	DWS Provided?	N/A
N/A	Landing Width (in)	N/A	N/A	DWS Contrast?	N/A
N/A	Landing Slope (%)	N/A	N/A	DWS Length (in)	N/A
N/A	Landing X Slope (%)	N/A	N/A	DWS Full Width?	N/A
N/A	Landing Curb? (Y/N)	N/A	N/A	DWS Offset (in)	N/A
N/A	Shared Landing?	N/A			
N/A	Gutter Ponding?	N/A	N/A	Gutter Slope (%)	N/A
N/A	Gutter Lip Ht (in)	N/A	N/A	Gutter X Slope (%)	N/A
N/A	Painted X Walk1?	No	N/A	Painted X Walk2?	N/A
	X Walk 1 Direction	To SW		X Walk 2 Direction	N/A
N/A	X Walk 1 Width (in)	N/A	N/A	X Walk 2 Width (in)	N/A
	X Walk 1 Slope (%)	1.4		X Walk 2 Slope (%)	N/A
	X Walk 1 X Slope (%)	4.1		X Walk 2 X Slope (%)	N/A

N/A	Ramp inside XWalk1?	N/A	N/A	Ramp inside XWalk2?	N/A
	Road Slope (%)	N/A	N/A	Clear Space?	N/A
	Road X Slope (%)	N/A	N/A	Clear Space to XWalk (in)	N/A
N/A	Any Obstructions?	N/A	N/A	Storm Grate/Utility Hazard?	N/A
	Obstruction Type			Storm Grate/Utility Type	
		N/A			N/A
			Yes	Surface Condition? (G/P)	Good

Remove & Replace Entire Ramp.
