Access Compliance Report

Public Rights-of-Way

(Curb Ramps)

Intersection ID: 23977	Main Street: REA_RD	Cross Street: WINDYRUSH_RD	Location: SW
ADA ID: 426815C92910	Ramp Type: Directional1	Initial Pass/Fail: Fail	Overall Compliance: No
		Severity Score: 12.5

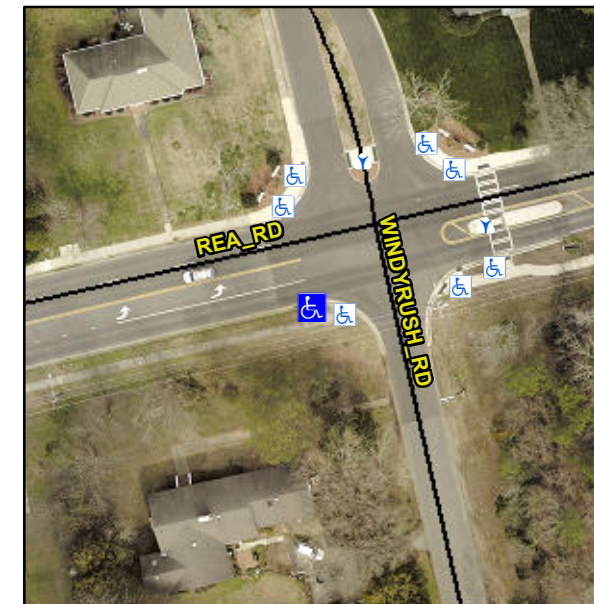
Compliance	Description	Data	Compliance	Description	Data
N/A	Ramp Length (in)	67.0	N/A	Grade Break?	N/A
Yes	Ramp Width (in)	60.0	N/A	Grade Break Slope (%)	0.0
No	Ramp Slope (%)	9.1	N/A	Grade Break XSlope (%)	0.0
Yes	Ramp XSlope (%)	0.2			
N/A	Flare Type LT	N/A	N/A	Flare Type RT	N/A
N/A	Flare Slope LT (%)	N/A	N/A	Flare Slope RT (%)	0.0
N/A	Flare Traversable LT?	N/A	N/A	Flare Traversable RT?	N/A
N/A	Landing Length (in)	0.0	N/A	DWS Provided?	N/A
N/A	Landing Width (in)	0.0	N/A	DWS Contrast?	N/A
N/A	Landing Slope (%)	0.0	N/A	DWS Length (in)	N/A
N/A	Landing X Slope (%)	0.0	N/A	DWS Full Width?	N/A
N/A	Landing Curb? (Y/N)	N/A	N/A	DWS Offset LT (in)	N/A
N/A	Shared Landing?	N/A	N/A	DWS Offset RT (in)	N/A
N/A	Gutter Ponding?	0.0	N/A	Gutter Slope (%)	N/A
N/A	Gutter Lip Ht (in)	0.0	N/A	Gutter X Slope (%)	N/A
N/A	Painted X Walk1?	No		Road Slope (%)	1.1
	X Walk 1 Direction	To N		Road X Slope (%)	0.0
	X Walk 1 Width (in)	N/A		Clear Space?	N/A

X Walk 1 Slope (%)	1.1	N/A	Clear Space to XWalk (in)	N/A
	X Walk 1 X Slope (%)	0.0	N/A	Storm Grate/Utility Hazard?	N/A
N/A	Ramp inside XWalk1?	N/A		Storm Grate/Utility Type	
N/A	Any Obstructions?	N/A			N/A
	Obstruction Type		Yes	Surface Condition? (G/P)	Good
			N/A	Curb Slope (%)	17.0

Possible Solutions:

Remove & Replace Entire Ramp.
