Access Compliance Report Public Rights-of-Way (Curb Ramps)

Intersection ID: 17465	ID: 17465 Main Street: CABOTWOOD_LN			Street:	RAMA_RD	Location:	SE		
ADA ID: 426BEBB54946	6BEBB54946 Ramp Type: PerpDiag			nitial Pass/Fail: Fail Overall Compliance: No				o Severity Score:	33.75
Codes/Mitigation Info/Possible Solution				Field Measurements/Component Compliance					
	163	Possible Solutions:		Compliance Description Data			Comp	Compliance Description Data	
		Remove & Replace Curb Ramp	With	N/A	Ramp Length (in)	54.0	No	Ramp Slope (%)	10.3
		Two New Directional Ramps or		No	Ramp Width (in)	40.0	No	Ramp XSlope (%)	5.5
		Equivalent.		N/A	Flare Type LT	N/A	N/A	Flare Type RT	N/A
				N/A	Flare Slope LT (%)	N/A	N/A	Flare Slope RT (%)	N/A
	Alert's Sta			N/A	Flare Traversable LT?	N/A	N/A	Flare Traversable RT?	N/A
	1444 14			N/A	Landing Length (in)	N/A	N/A	DWS Provided?	N/A
2	112 211	Surveyor Notes:		N/A	Landing Width (in)	N/A	N/A	DWS Contrast?	N/A
S S	Call A	N/A		N/A	Landing Slope (%)	N/A	N/A	DWS Length (in)	N/A

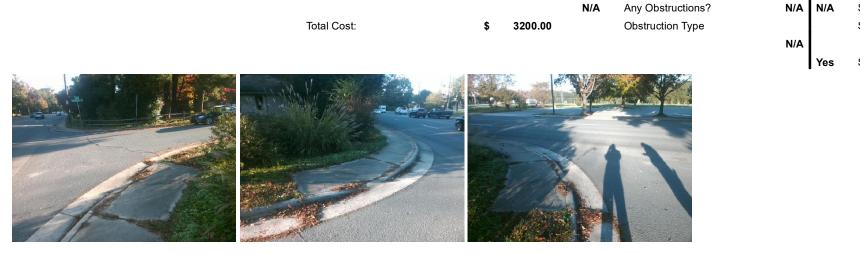
Real Providence	87			N/A	Landing X Slope (%)	N/A	N/A	DWS Full Width?	N/A
No contraction of the second sec				N/A	Landing Curb? (Y/N)	N/A	N/A	DWS Offset (in)	N/A
				N/A	Shared Landing?	N/A			
	PROW/ADA:		N/A	Gutter Ponding?	N/A	N/A	Gutter Slope (%)	N/A	
Not Found, R304.5.1, R304.2.2 R304.5.3				N/A	Gutter Lip Ht (in)	N/A	N/A	Gutter X Slope (%)	N/A
				N/A	Painted X Walk1?	No	N/A	Painted X Walk2?	No
					X Walk 1 Direction	To NE		X Walk 2 Direction	To NW
				N/A	X Walk 1 Width (in)	N/A	N/A	X Walk 2 Width (in)	N/A
Street 1 Name	CABOTWOOD LN	-			X Walk 1 Slope (%)	0.3		X Walk 2 Slope (%)	4.0
Stop Condition-Street 2	StopSign				X Walk 1 X Slope (%)	4.5		X Walk 2 X Slope (%)	2.5
Street 2 Name	RAMA RD			N/A	Ramp inside XWalk1?	N/A	N/A	Ramp inside XWalk2?	N/A
Stop Condition-Street 1	None				Road Slope (%)	4.5	N/A	Clear Space?	N/A
					Road X Slope (%)	1.3	N/A	Clear Space to XWalk (in)	N/A
				N/A	Any Obstructions?	N/A	N/A	Storm Grate/Utility Hazard?	N/A

es Surface Condition? (G/P)

Good

Total Cost: \$	3200.00		Obstruction Type			Storm Grate/Utility Type	
						N/A			N/A
