# Access Compliance Report

## Public Rights-of-Way

Intersection ID: 20292	Main Street: BENTLEY_OAKS_LN	Cross Street: SARDIS_RD	Location: NW
ADA ID: 4274617405A4	Ramp Type: PerpDiag	Initial Pass/Fail: Fail	Overall Compliance: No
Severity Score: 43.75			
Codes/Mitigation Info/Possible Solution		Field Measurements/Component Compliance

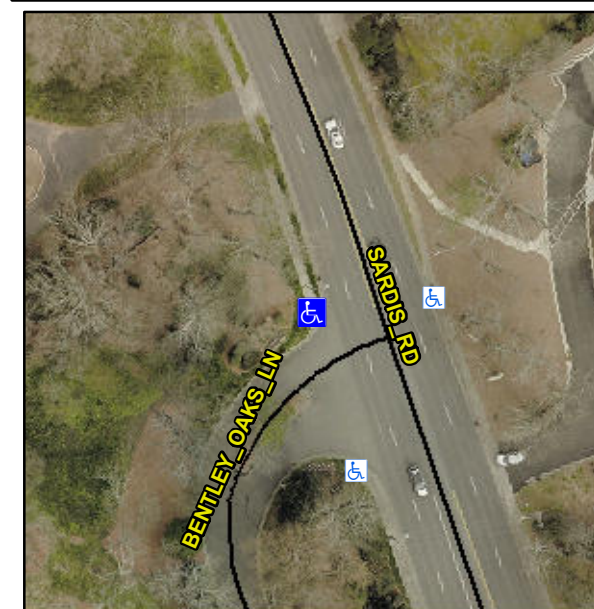
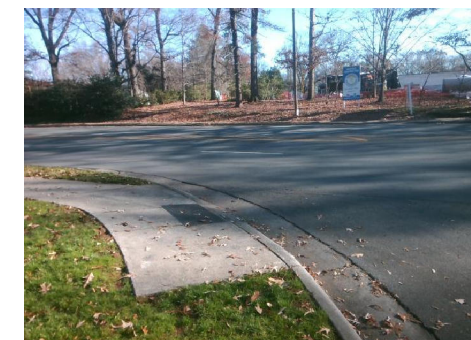
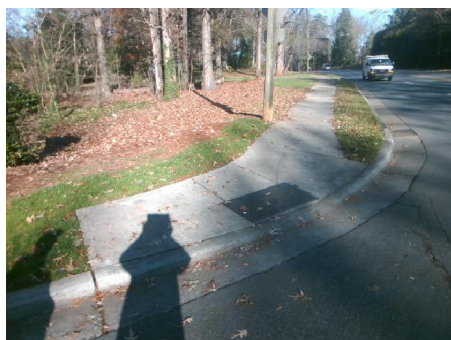
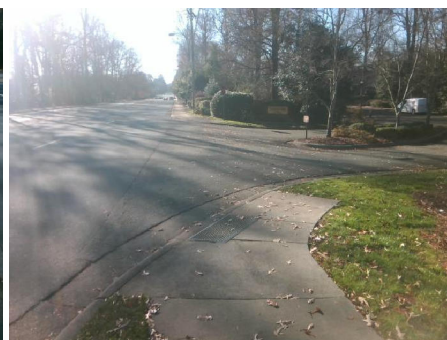
**Not Found, R304.5.1, R304.2.2, R304.5.3**

Compliance	Description	Data	Compliance	Description	Data
N/A	Ramp Length (in)	67.0	No	Ramp Slope (%)	12.8
No	Ramp Width (in)	34.5	No	Ramp XSlope (%)	4.7
N/A	Flare Type LT	N/A	N/A	Flare Type RT	N/A
N/A	Flare Slope LT (%)	N/A	N/A	Flare Slope RT (%)	N/A
N/A	Flare Traversable LT?	N/A	N/A	Flare Traversable RT?	N/A
N/A	Landing Length (in)	N/A	N/A	DWS Provided?	N/A
N/A	Landing Width (in)	N/A	N/A	DWS Contrast?	N/A
N/A	Landing Slope (%)	N/A	N/A	DWS Length (in)	N/A
N/A	Landing X Slope (%)	N/A	N/A	DWS Full Width?	N/A
N/A	Landing Curb? (Y/N)	N/A	N/A	DWS Offset (in)	N/A
N/A	Shared Landing?	N/A			
N/A	Gutter Ponding?	N/A	N/A	Gutter Slope (%)	N/A
N/A	Gutter Lip Ht (in)	N/A	N/A	Gutter X Slope (%)	N/A
N/A	Painted X Walk1?	No	N/A	Painted X Walk2?	No
	X Walk 1 Direction	To S		X Walk 2 Direction	To E
N/A	X Walk 1 Width (in)	N/A	N/A	X Walk 2 Width (in)	N/A
	X Walk 1 Slope (%)	1.5		X Walk 2 Slope (%)	3.9
	X Walk 1 X Slope (%)	5.3		X Walk 2 X Slope (%)	1.3

N/A	Ramp inside XWalk1?	N/A	N/A	Ramp inside XWalk2?	N/A
	Road Slope (%)	4.1	N/A	Clear Space?	N/A
	Road X Slope (%)	2.0	N/A	Clear Space to XWalk (in)	N/A
N/A	Any Obstructions?	N/A	N/A	Storm Grate/Utility Hazard?	N/A
	Obstruction Type			Storm Grate/Utility Type	
		N/A			N/A
		Yes		Surface Condition? (G/P)	Good

**Remove & Replace Curb Ramp With Two New Directional Ramps or Equivalent.**
