# Access Compliance Report

## Public Rights-of-Way

### (Curb Ramps)

| Intersection ID: 10032191 | | Main Street: MORRISON_BV | | Cross Street: N/A | | Location: NE | | | | | | | | | | | | | |

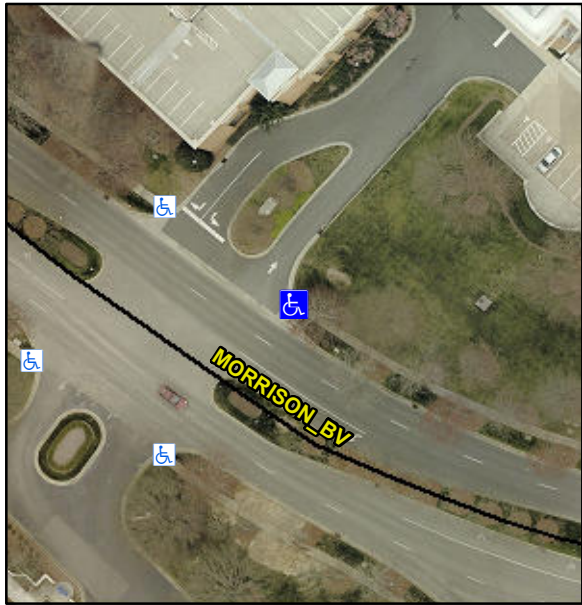
| <div></div> <div>Street 1 NameENTRANCE</div> <div>Stop Condition-Street 1StopSign</div> <div>Street 2 NameN/A</div> <div>Stop Condition-Street 2N/A</div> | | | | Possible Solutions: | | Compliance | | Description | | Data | | Compliance | | Description | | Data | | | |
| | | | | | | No | | Ramp XSlope (%) | | 7.1 | | | | | | | | | |
| | | | | | | | | | | N/A | | N/A | | Curb Slope (%) | | 9.9 | | | |

| | | | | Remove & Replace Entire Ramp. | | N/A | | Ramp Length (in) | | 42.0 | | N/A | | Grade Break? | | N/A | | N/A | |
